## MEMORANDUM

**Re:** Stream and Wetland Summary  
Brent Spence Bridge Corridor  
KYTC Item No. 6-17.00  
ODOT PID 116649

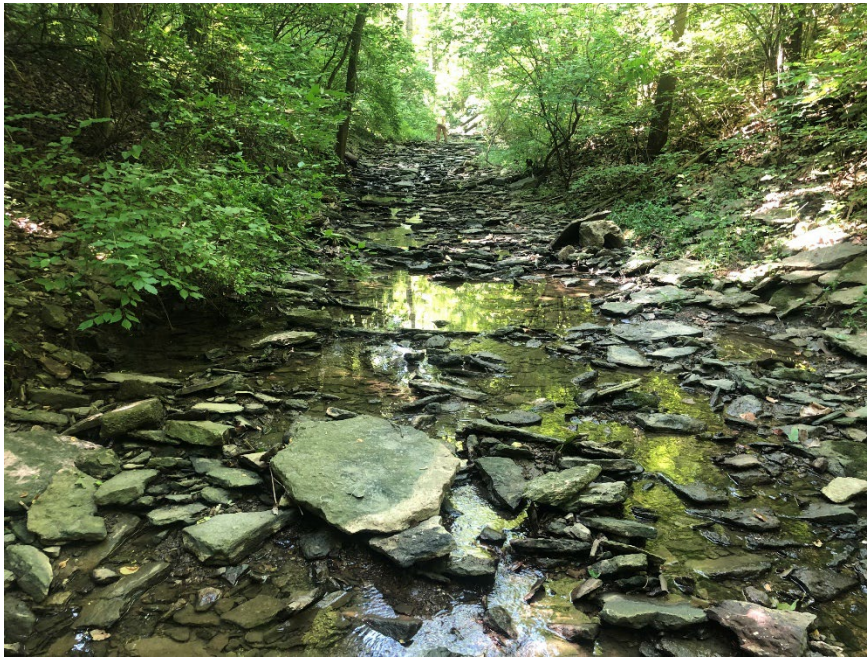
- Stream PER 1 is a poor-quality perennial stream that flows under the existing road, and into Pleasant Run Creek.
- Stream INT 12 is a poor-quality intermittent stream that flows into Stream S01.

### **Stream PER 1, Perennial, RBP Score 117**

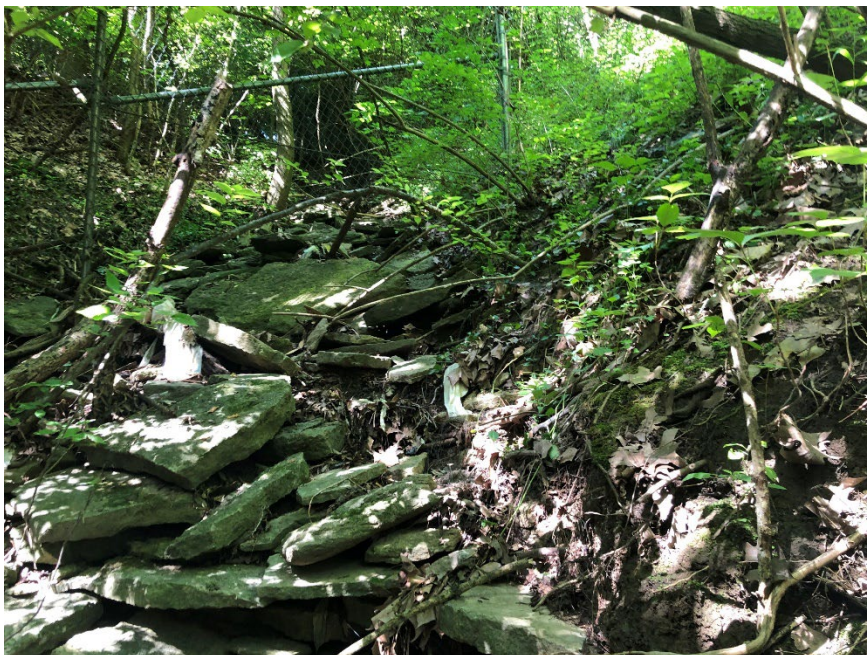
### **Stream INT 12, Intermittent, RBP Score 82**

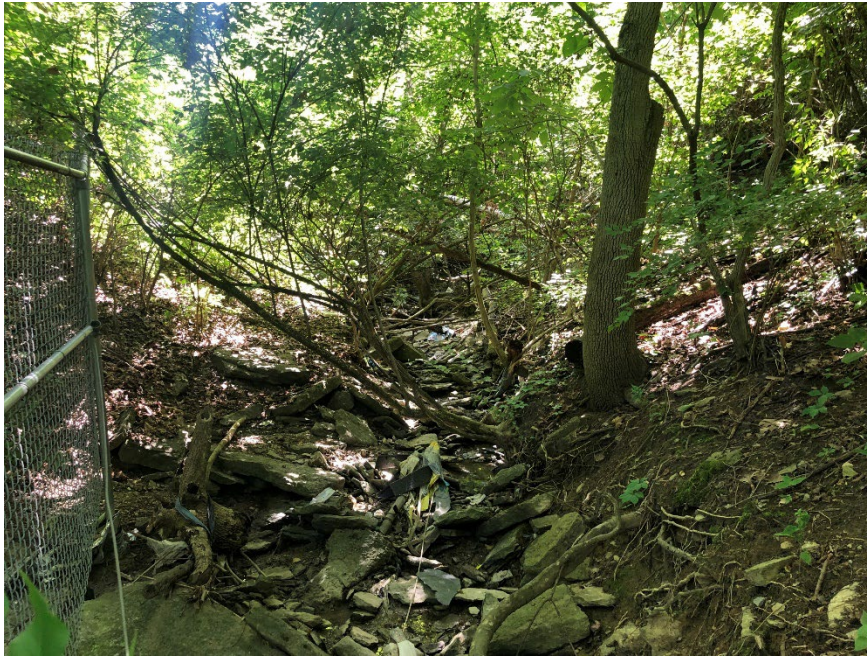
- Stream INT 14 is a poor-quality intermittent stream that flows into Stream S01.
- Stream PER 2 is a poor-quality perennial stream that flows into Banklick Creek.

**Stream INT 14, Intermittent, RBP Score 84**

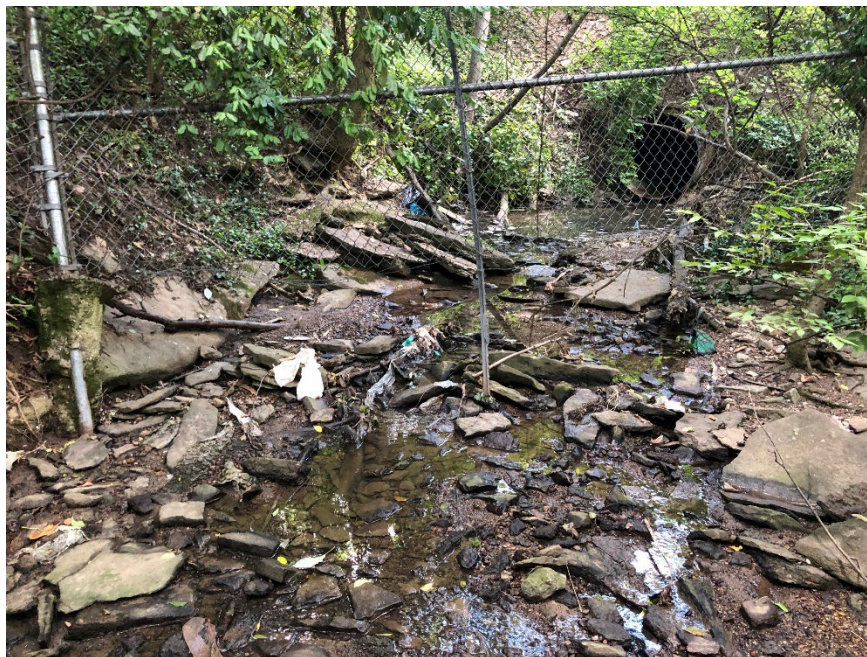
**Stream PER 2, Perennial, RBP Score 108**

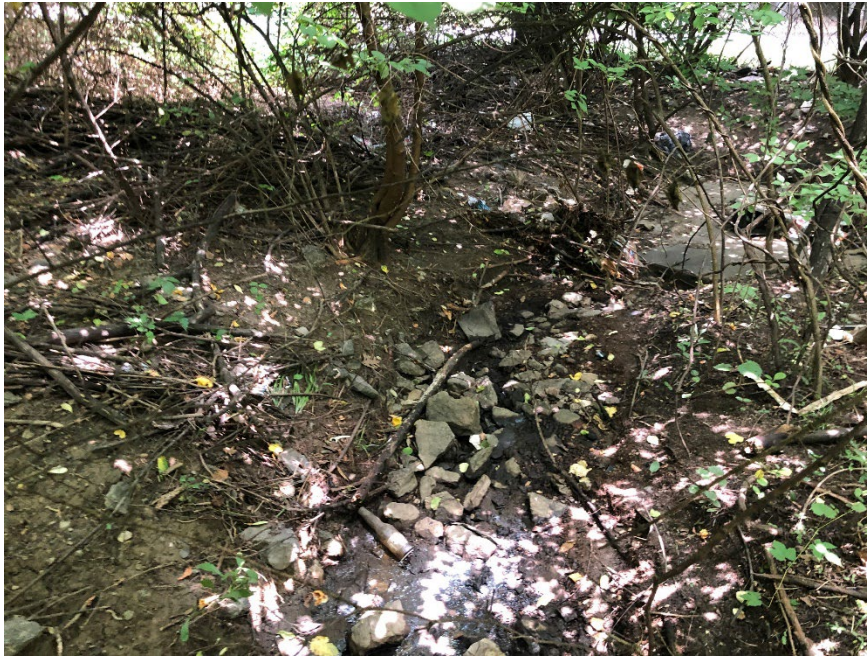
- Stream INT 15 is a poor-quality intermittent stream that flows into Stream S07.
- Stream INT 16 is a poor-quality intermittent stream that flows into Stream S06.

**Stream INT 15, Intermittent, RBP Score 78**

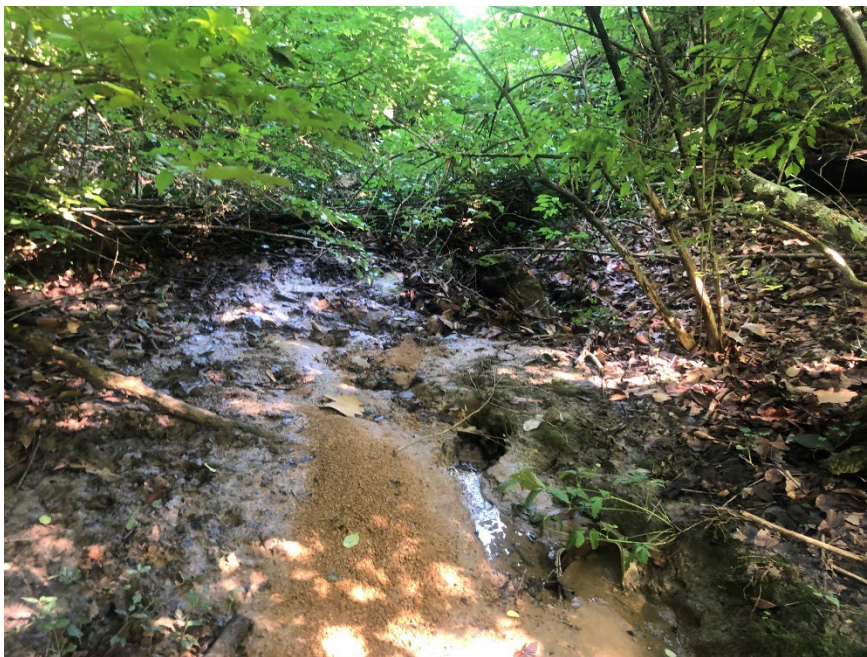
**Stream INT 16, Intermittent, RBP Score 65**

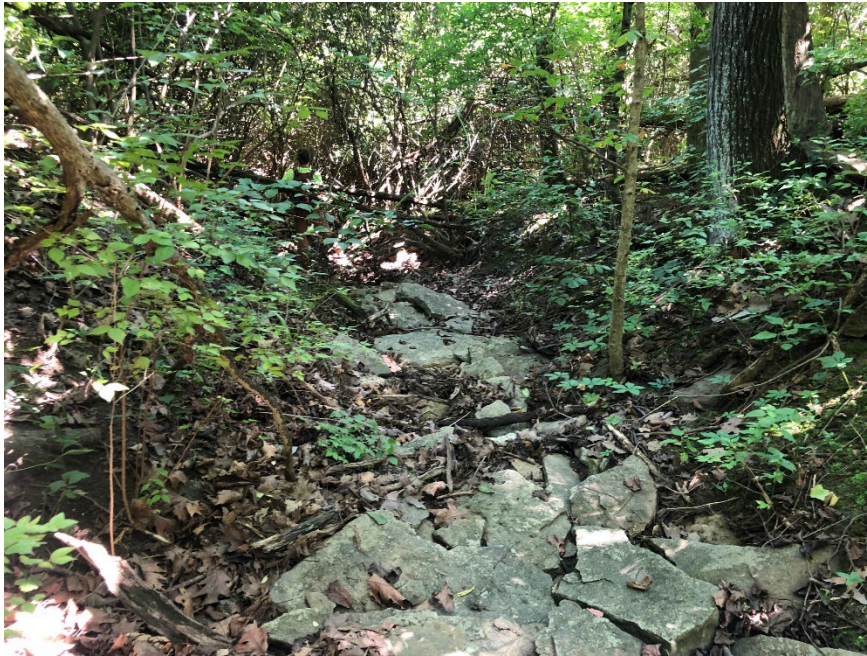
- Stream INT 17 is a poor-quality intermittent stream that flows into Wetland W3.
- Stream INT 18 is a poor-quality intermittent stream that flows into Stream S11.

**Stream INT 17, Ephemeral, RBP Score 97**

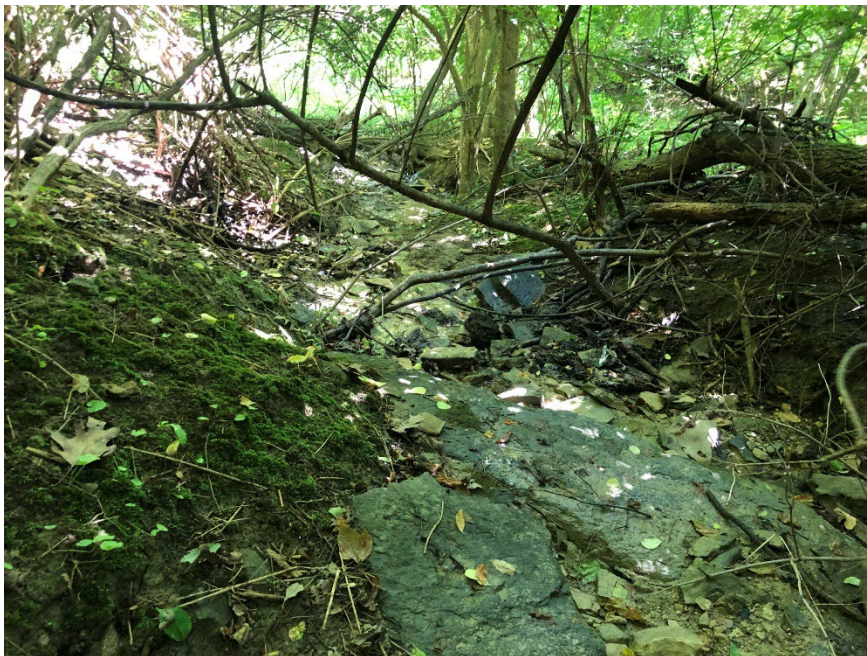
**Stream INT 18, Intermittent, RBP Score 97**

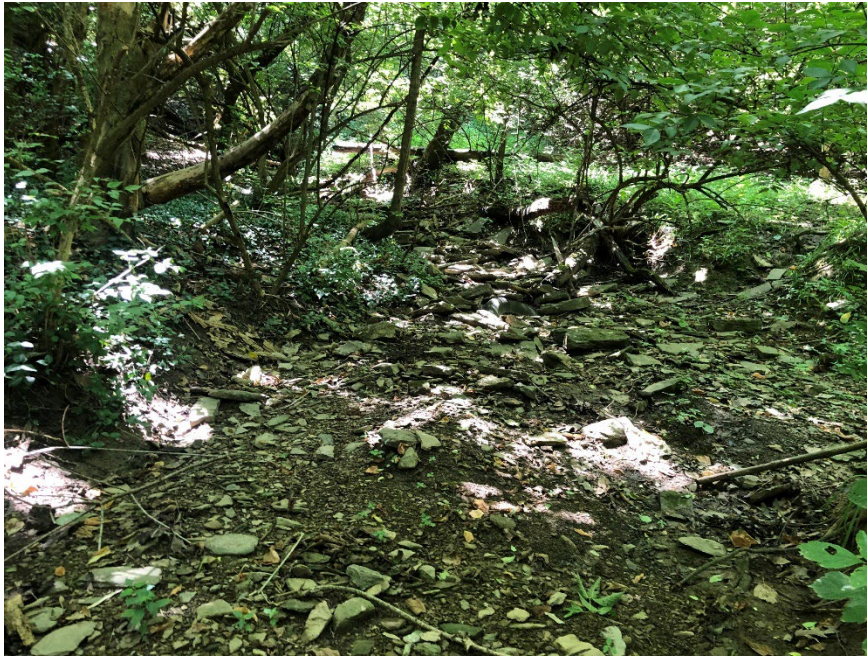
- Stream INT 6 is a poor-quality intermittent stream that flows into Stream S11.
- Stream INT 19 is a poor-quality intermittent stream that flows into Wetland W4.

**Stream INT 6, Intermittent, RBP Score 90**

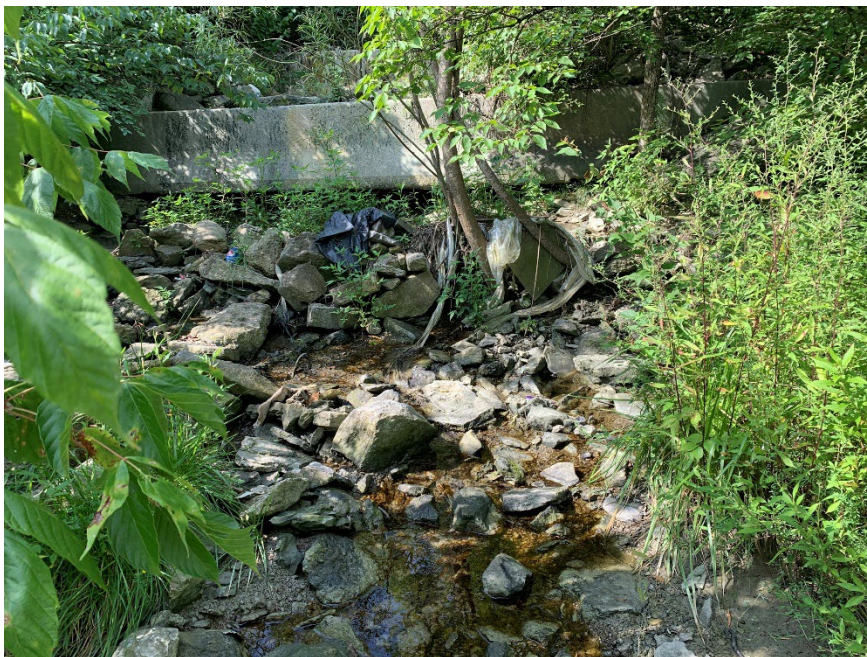
**Stream INT 19, Intermittent, RBP Score 90**

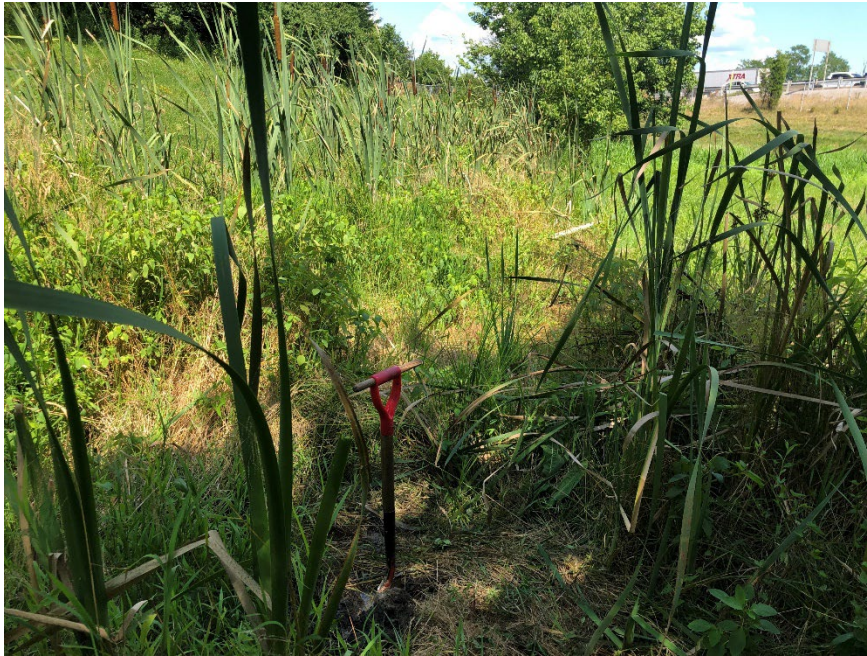
**Wetland WET 6, PEM**

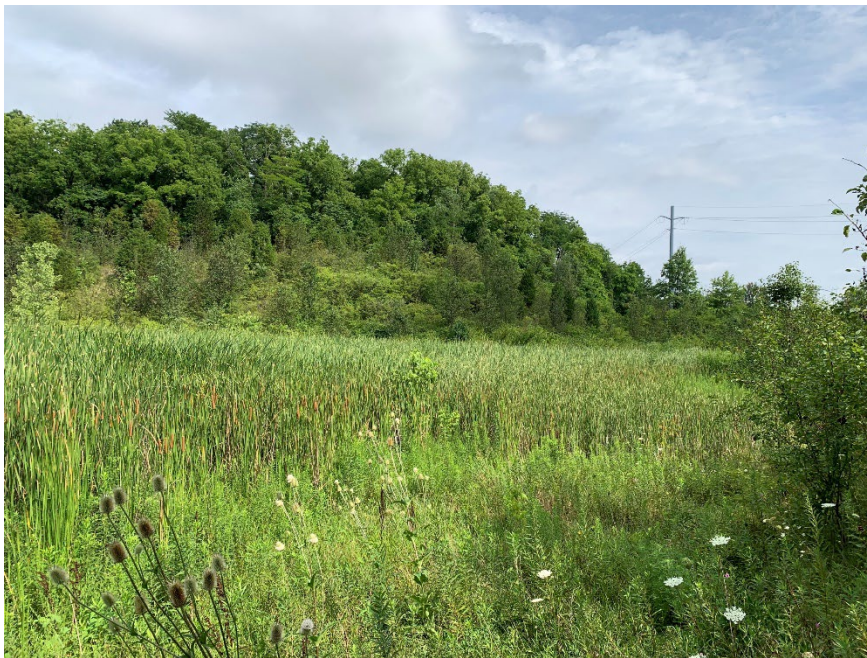
**Wetland WET 8, PEM**
