BRENT SPENCE BRIDGE PROJECT
Phase I History/Architecture
Re-evaluation Survey
HAM-71/75-0.00/0.22; PID 89068
City of Cincinnati, Hamilton County, Ohio

Submitted to ODOT-D08
July 2022

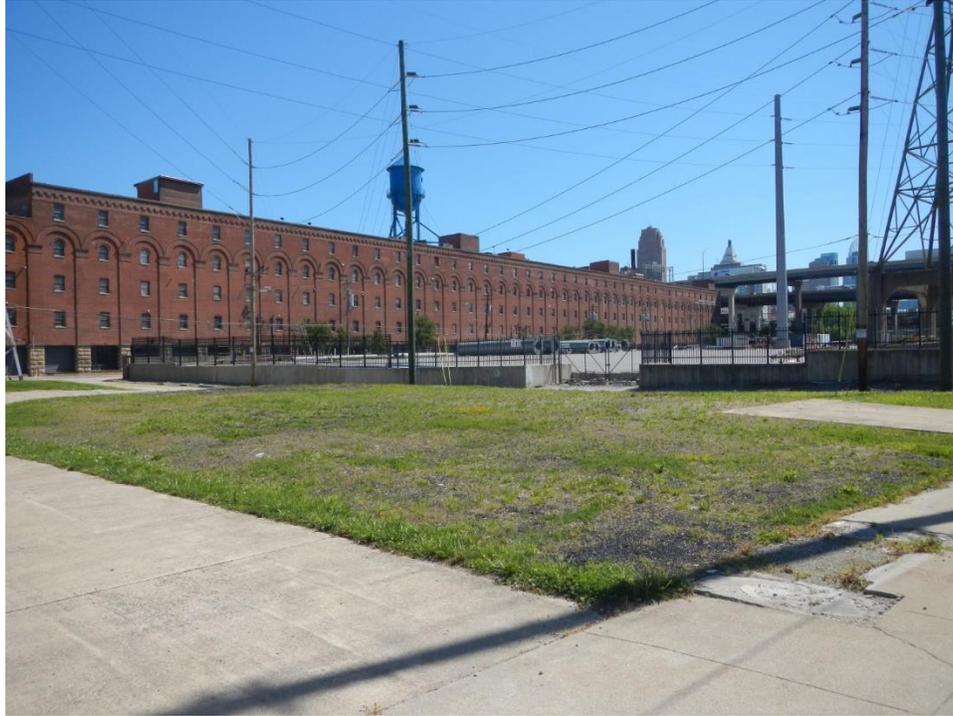
Plate 1. Former location of the John Mueller House, 724 Mehring Way, looking northeast.

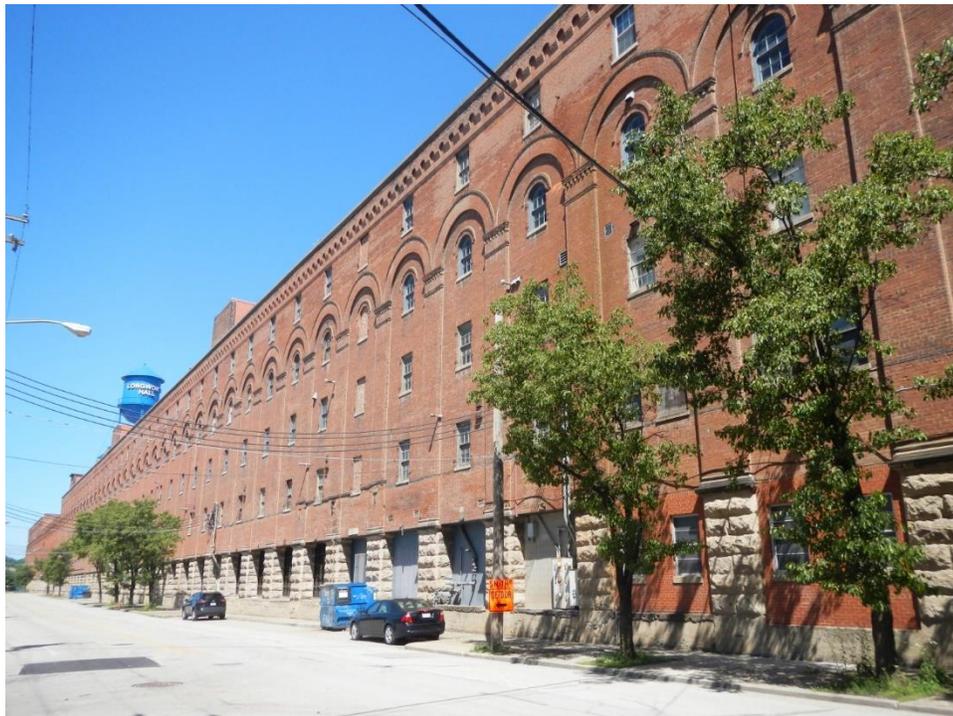
Plate 2. B&O Freight Terminal/Longworth Hall, 700 Pete Rose Way, looking west.

- Installation of exterior storm windows,
- Restoration of the east wall to an approximation of its original appearance using salvaged materials,
- Masonry repairs, including repair or replacement of bricks as warranted, tuck-pointing, and brick cleaning,
- Plaque/Interpretive signage will be constructed,
- The original lettering across the top of the building will be refurbished,
- All materials removed will be returned to the building owner, and
- ODOT will have follow up discussions with the owner regarding contracting methods.

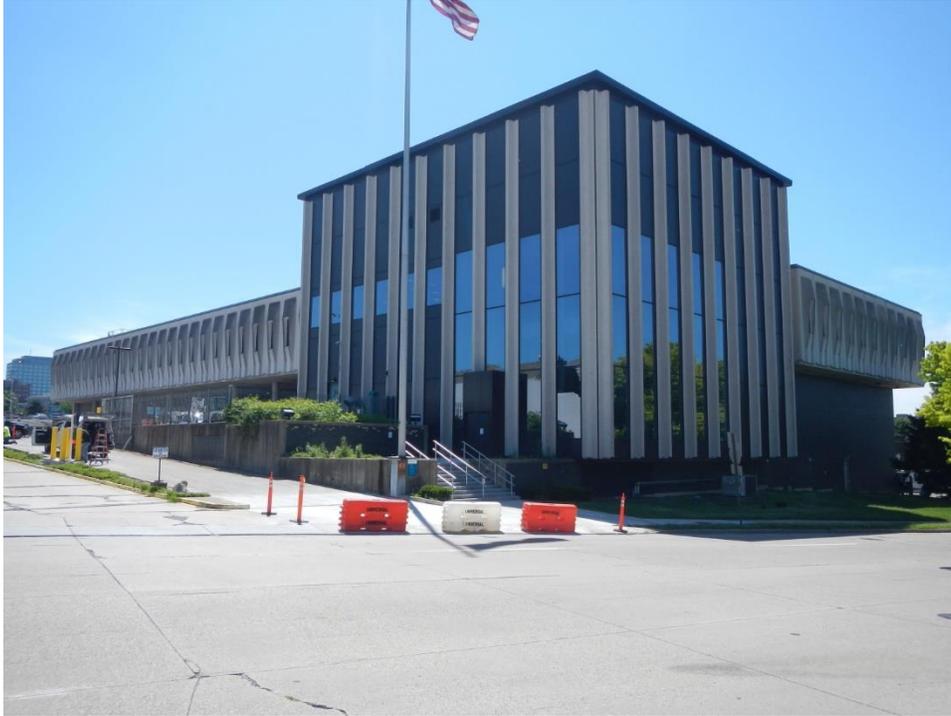
Plate 3. AL01, 424 Gest Street, Duke Energy, looking southeast.

Under Criterion C, AL01 does not embody the distinctive characteristics of a type, period, or method of construction. Although the building has a high level of integrity, the building does not have the primary characteristics of a particular stylistic expression of Mid-Century Modern architecture. AL01 retains its integrity of location, design, setting, materials, workmanship, feeling, and association. AL01 lacks historical and architectural significance and is recommended as not eligible for listing in the NRHP.

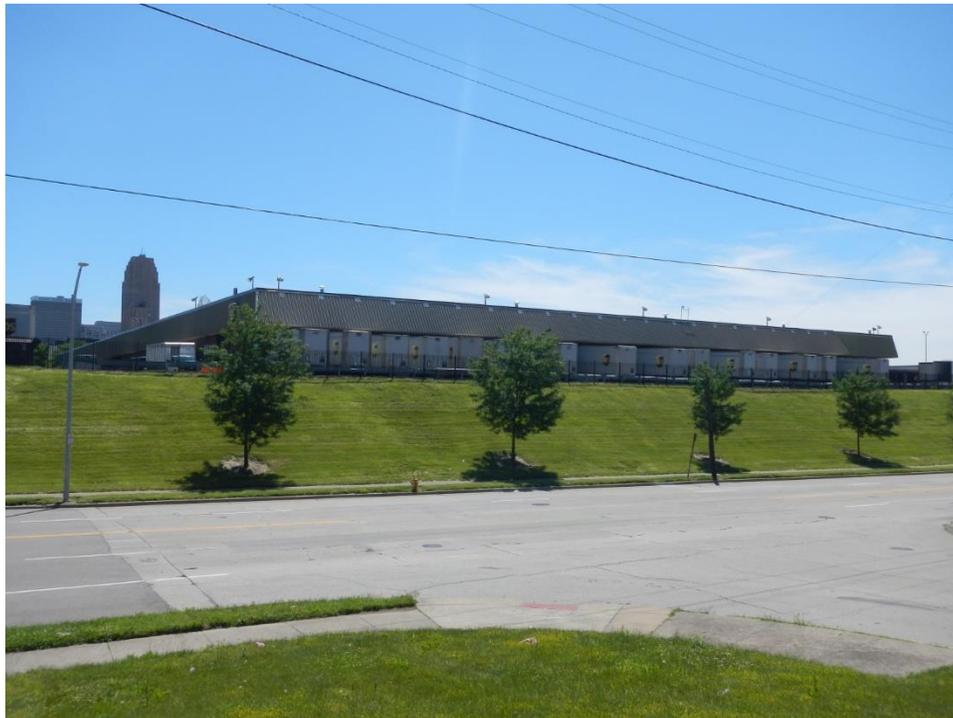
Plate 4. AL02, 500 Gest Street, UPS, looking southeast.

Under Criterion C, AL02 does not embody the distinctive characteristics of a type, period, or method of construction. The building is an unremarkable example of a warehouse and distribution facility. The building retains its integrity of location, design, setting, materials, workmanship, feeling, and association. AL02 lacks historical and architectural significance and is recommended as not eligible for listing in the NRHP.

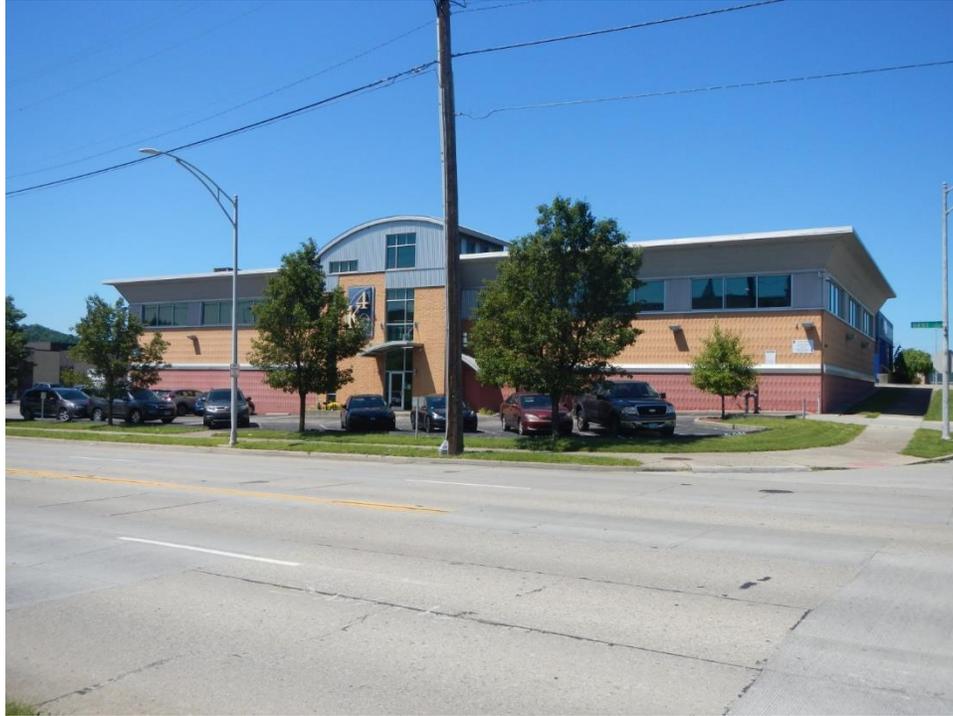
Plate 5. AL03, 555 Gest Street, K4Places, looking southwest.

Under Criterion C, AL03 does not embody the distinctive characteristics of a type, period, or method of construction. Apart from the use of textured concrete block for its exterior walls, the original building was a nondescript warehouse with little fenestration. The building has lost its integrity of design, materials, and workmanship due to alterations and is recommended as not eligible for listing in the NRHP due to this loss of integrity.

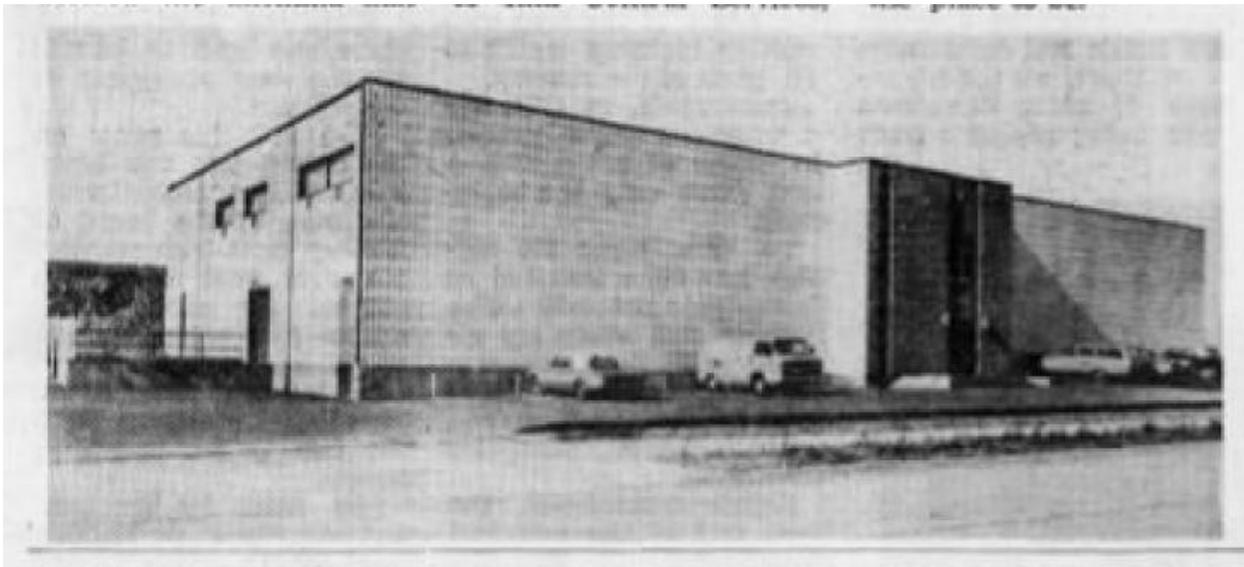
AL03 is three-story office building constructed in 1963 (Figure 4, Sheets 2 and 3; Table 2; Plate 5). The building has a flat roof with a metal pent roof at the top of the north, south, and east walls. Due to a change of grade, only the front (east) and south sides of the building express the full three stories. The first two floors are concrete block, with blocks molded in a diamond shape on their face. The lower part of the west (rear) wall is concrete. The third floor consists of window bays alternating with metal panels. The window bays consist of strips of two, three, or four windows, depending on their location. The main entrance in the center of the east wall projects slightly forward from the rest of the wall and is constructed of brick, with a metal-clad penthouse. A loading dock is located at the south wall.

Photo 1. AL03, 555 Gest Street, from *Cincinnati Enquirer* Queensgate I Day supplement 23 September 1971:7.

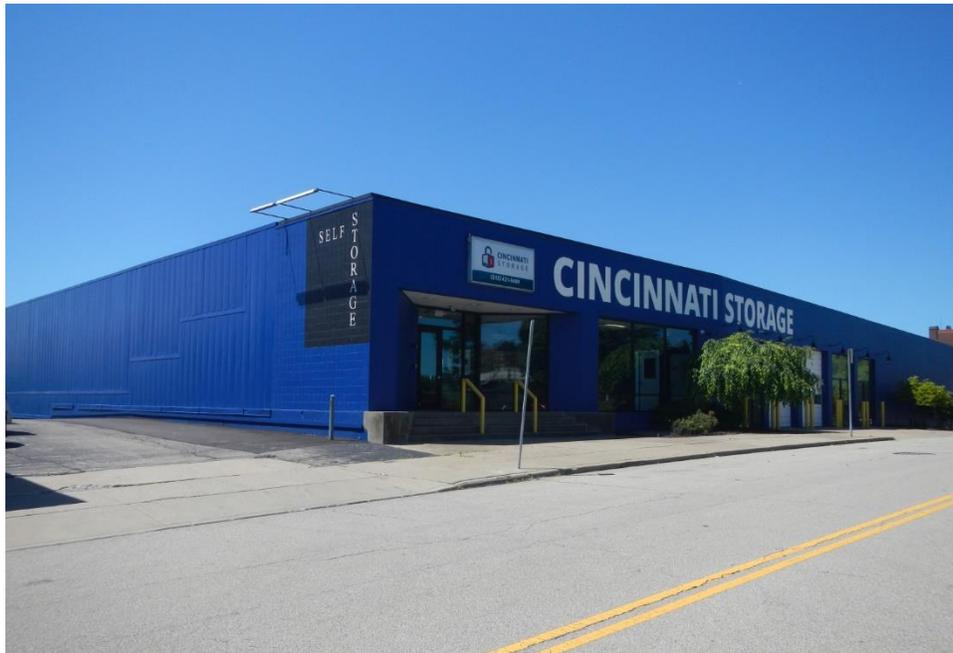
AL04 is a one-story warehouse building constructed in 1970 (Figure 4, Sheets 2 and 3; Table 2; Plate 6). The building has a flat roof and a concrete foundation. The north (front) wall of the building constructed of square concrete blocks; the rest of the building has metal panels covering the walls. Plate glass windows and a recessed entrance with glass doors are located in the north wall. Garage bays with metal doors are found in the north and west walls. Two former garage bays in the north wall have been replaced with plate glass windows. Several bays of plate glass windows also are found in the south wall. Research was unable to identify the original occupant of this building, but, by the late 1980s, Cincinnati Belting and Transmission Co. was using the building (*Cincinnati Enquirer* 30 December 1988:B-9).

Plate 6. AL04, 737 W. Sixth Street, Cincinnati Storage, looking southwest.

Under Criterion C, AL04 does not embody the distinctive characteristics of a type, period, or method of construction. The building is an unremarkable example of a warehouse-type structure. In addition, fenestration changes in the north (front) wall and the addition of rows of storage containers to the interior of the building have removed the building's integrity of design and feeling. AL04 lacks significance and integrity and is recommended as not eligible for listing in the NRHP.

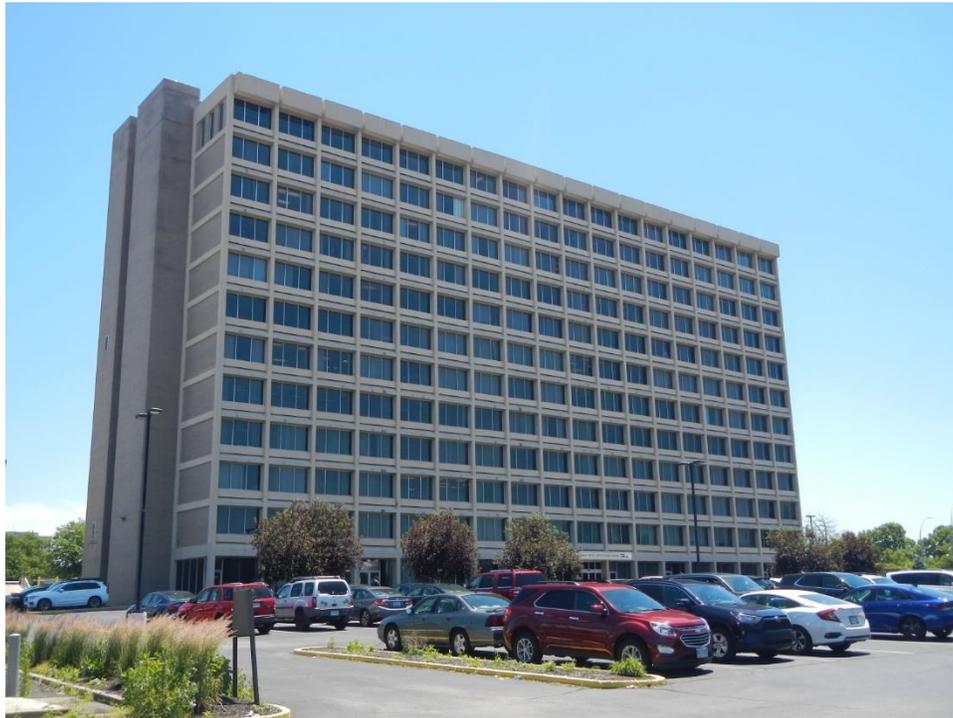
Plate 7. AL05, 644 Linn Street, Gateway West Office Park Tower, looking southeast.

Under Criterion A, AL05 does not have associations with events or trends important in history. AL05 is not a particularly early building in Queensgate I, but is one of the tallest, tied with AL15 in the number of floors. The Holiday Park Office Complex also was the largest multi-tenant office complex in Queensgate I. However, the integrity of the property has been diminished with the demolition of the two five-story buildings and the replacement of the plaza with additional parking. The office building complex has been altered sufficiently that it can no longer convey the full scope and layout of the original property.

feeling. AL05 lacks historical and architectural significance and is recommended as not eligible for listing in the NRHP.

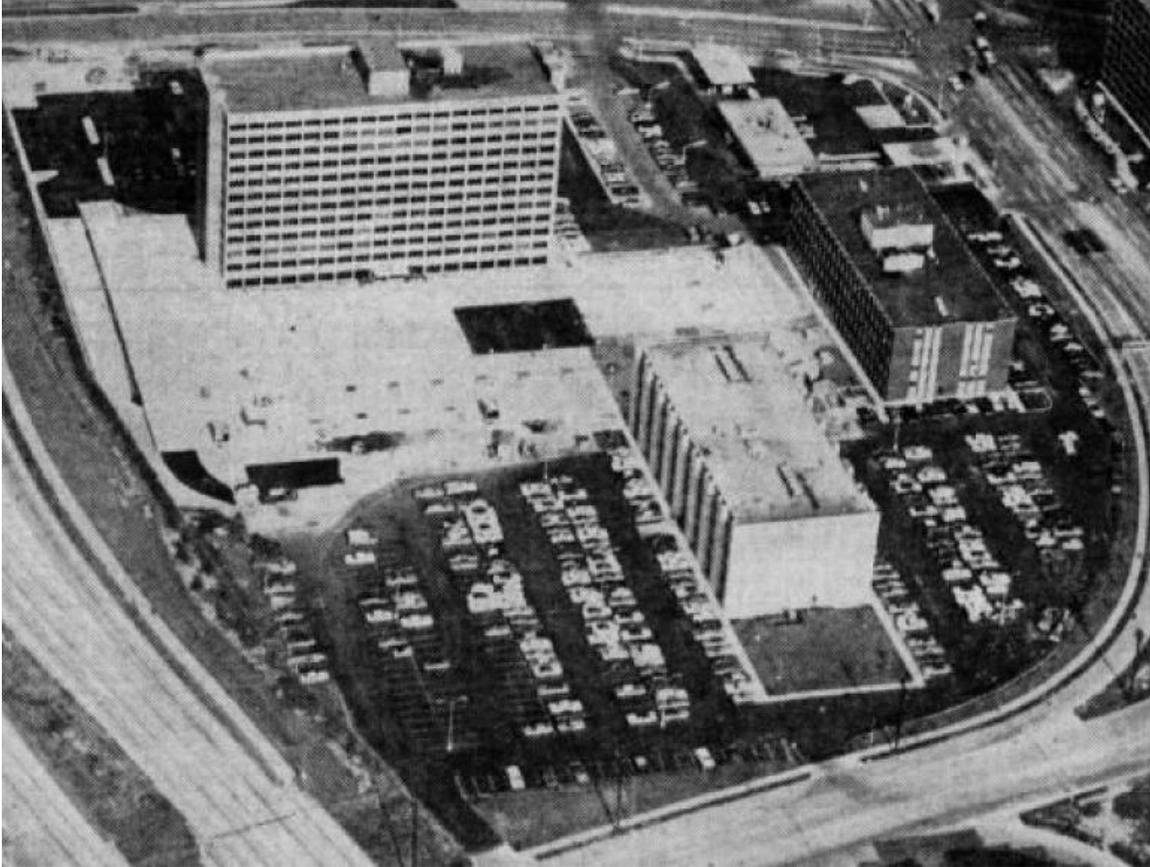
AL05 was originally the Holiday Park Tower and was part of a grouping of three buildings called the Holiday Park Office Complex (*Cincinnati Enquirer* Queensgate I Day supplement, 23 September 1971:1, 7, 11) [Photos 2 and 3]. The complex was renamed the Gateway West Office Park in 2013 (Andrews 2013:B1). At that time, the complex still retained the 12-story tower and two five-story buildings, which Google Earth aerial photographs show were demolished in 2018. A 1971 profile stated that the office complex housed nearly one-half of the companies that then called Queensgate their home. The profile touted a beautifully landscaped plaza complete with water fountain as the focal point of the complex, year-round air conditioning, free parking, and a postal station (*Cincinnati Enquirer* Queensgate I Day supplement, 23 September 1971:11). The plaza was located on the west side of AL05 and is now part of the west parking lot.

Photo 3. AL05, 644 Linn Street, from *Cincinnati Enquirer* Queensgate I Day supplement 23 September 1971:1.

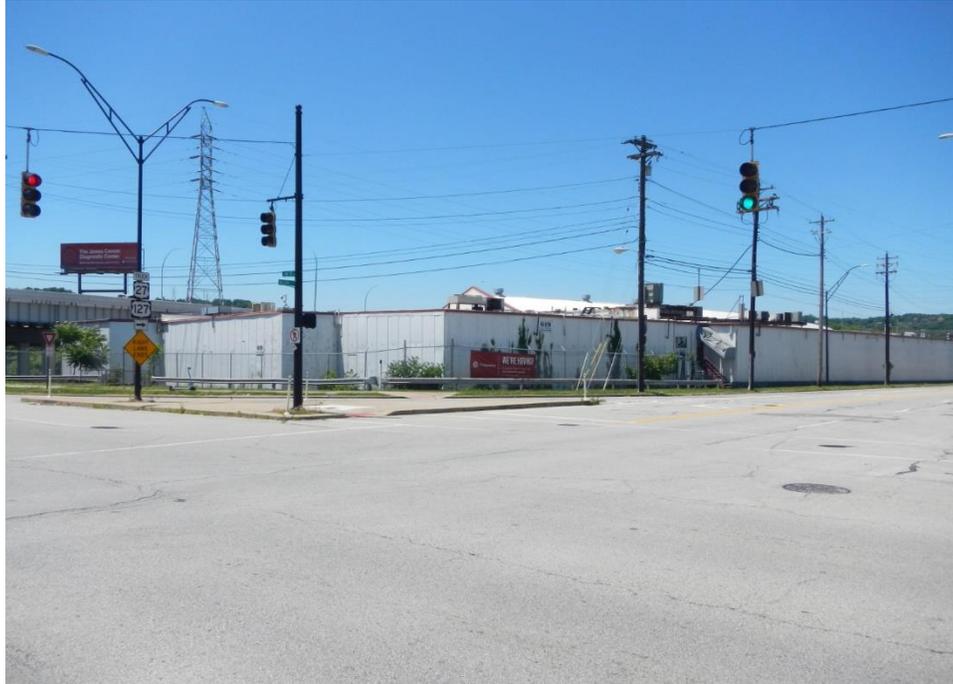
AL06 is a one-story warehouse building constructed in 1971 (Figure 4, Sheet 3; Table 2; Plate 8). The building has a rough L-plan with the short leg on the east. Most of the building has a flat roof, but the southern half of the center section has a shallow-pitched gable roof. The building has a concrete foundation. Concrete block walls are visible on the west and south sides, but the north and east walls are covered with metal panels. The south wall mostly consists of loading docks.

The C. A. Squeri Company purchased a former B&O Railroad warehouse at Linn and Dalton streets in 1971 and rebuilt the facility into a new concrete block warehouse and distribution center, keeping only the foundation of the former freight warehouse. The new facility gave the company 30,000 square feet, 14 loading doors, and a three-car railroad siding (*Cincinnati Post* 21 June 1971:19). The C. A. Squeri Company, later Squeri Foods, Inc., was a food wholesaler providing fresh and frozen food to restaurants and institutions (such as hospitals). The Squeri family started in the fruit and vegetable trade in 1924. The building was expanded in 1987 (Paschal 1987:4-A).

Plate 8. AL06, 619 Linn Street, Chefs Warehouse, looking southwest.

Under Criterion C, AL06 does not embody the distinctive characteristics of a type, period, or method of construction. The building is an unremarkable example of a warehouse with alterations and expansions. The building lacks integrity of design due to non-historic additions and integrity of materials due to much of the concrete block building being resided with metal paneling. AL06 lacks significance and integrity and is recommended as not eligible for listing in the NRHP.

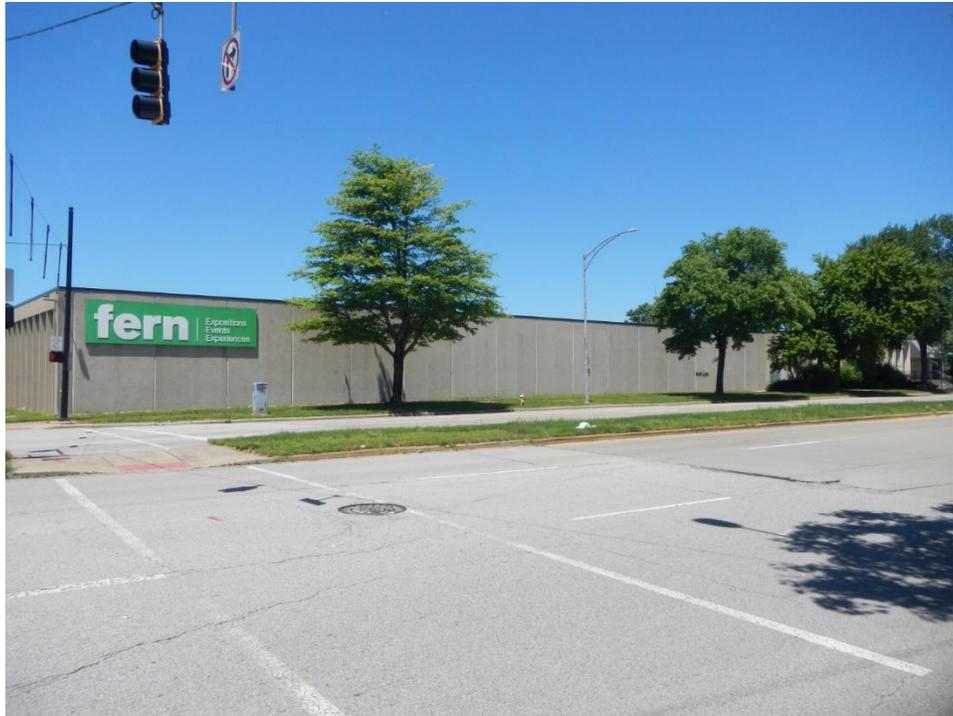
Plate 9. AL07, 645 Linn Street, George Fern Company, looking northwest.

Under Criterion C, AL07 does not embody the distinctive characteristics of a type, period, or method of construction. The building is an unremarkable example of a warehouse. The building retains integrity of location, design, setting, materials, workmanship, feeling, and association. AL07 lacks historical and architectural significance and is recommended as not eligible for listing in the NRHP.

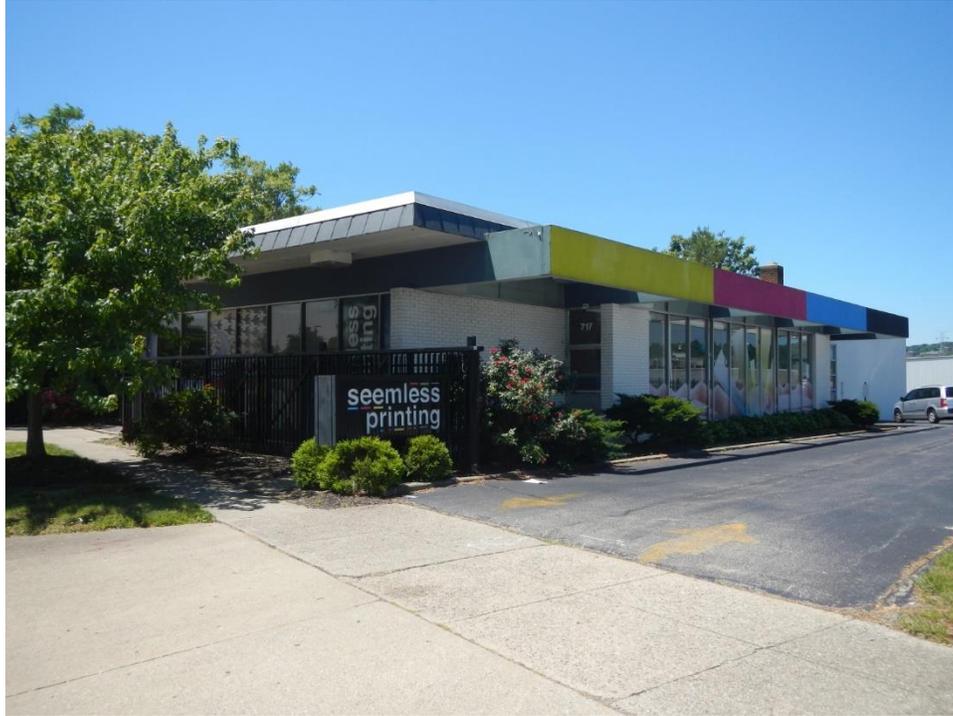
AL08 is a one-story commercial building constructed in 1965 (Figure 4, Sheet 3; Table 2; Plate 10). The building has a flat roof with a wide overhang carried on concrete beams. On the north wall, the beams project forward of the overhang to carry a lateral beam along the north side of the building; this originally held a sign for the bank that built the structure (Photo 4). The original building is clad in brick veneer; a ca. 2012 addition to the west has concrete block walls and no roof overhangs. Full-height plate glass windows are found on the east (front) wall and the original north wall. Narrow plate glass windows are found under the roof overhang along the original south wall. The original entrance near the building's northeast corner has been converted to a window. A drive-thru window is also located along the south wall.

Plate 10. AL08, 717 Linn Street, Seamless Printing, looking southwest.

Under Criterion C, AL08 does not embody the distinctive characteristics of a type, period, or method of construction. The building is an unremarkable example of a mid-twentieth century bank branch and has been altered through the rear addition and the closing off of the former main entrance at the building's northeast corner. AL08 has lost integrity of design due to the addition and entrance alteration. AL08 lacks significance and integrity and is recommended as not eligible for listing in the NRHP.

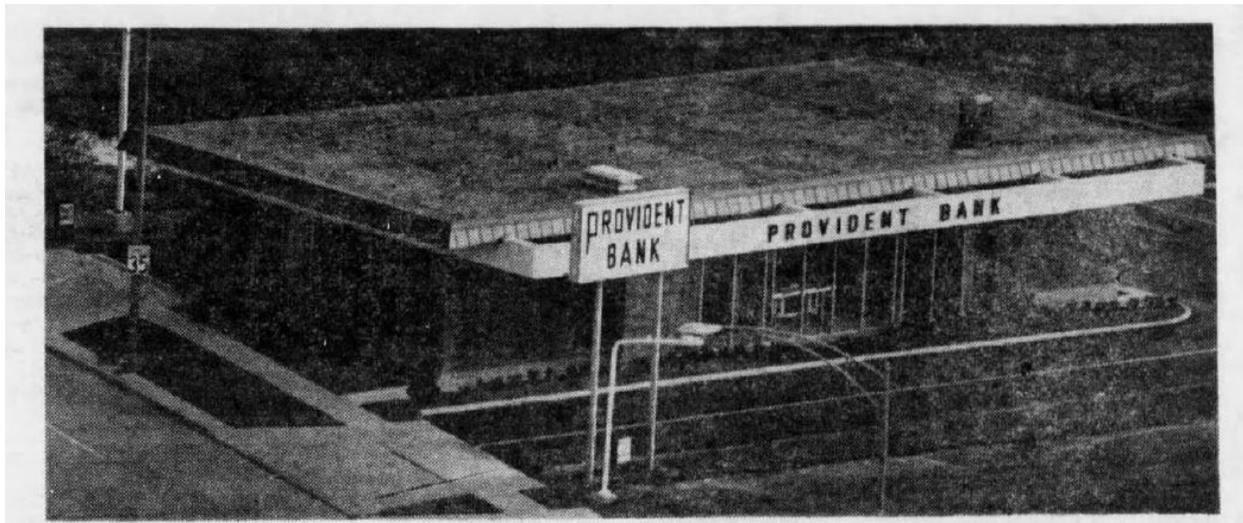
Photo 4. AL08, 717 Linn Street, from *Cincinnati Enquirer* Queensgate I Day supplement 23 September 1971:9.

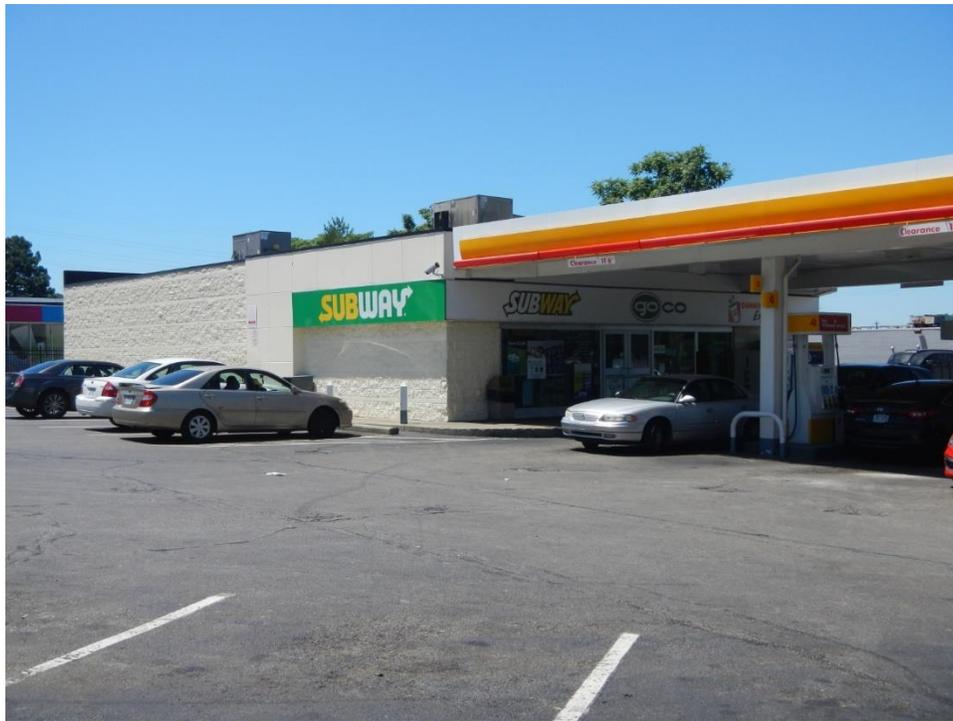
Plate 11. AL09, 901 W. Eighth Street, GoCo Shell/Dunkins/Subway, looking southwest.

Under Criterion C, AL09 is an unremarkable and extensively remodeled example of a twentieth century gas station. The building does not embody the distinctive characteristics of a type, period, or method of construction. The building has lost its integrity of design, materials, workmanship, and feeling. Lacking significance and integrity, AL09 is recommended as not eligible for listing in the NRHP.

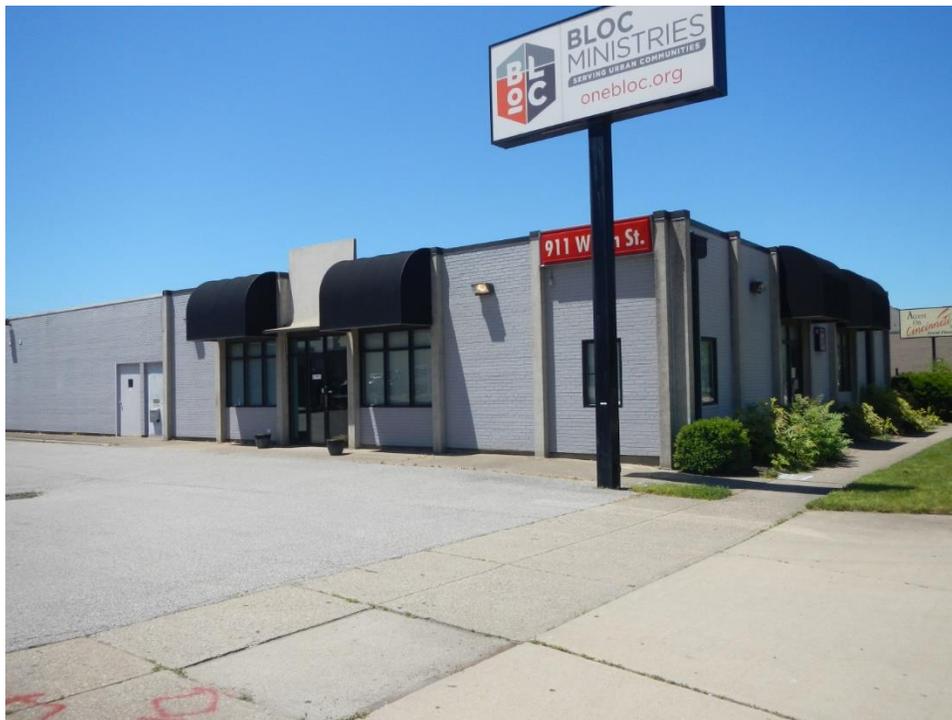
AL10 and AL11 are a single building, but have different owners and addresses in county tax records and so are discussed here separately. AL10 is a one-story warehouse building constructed in ca. 1969 (Figure 4, Sheet 3; Table 2; Plate 12). The building has a flat roof, a concrete foundation, and brick veneer walls. Concrete posts divide the walls into bays. Entrances with glass doors are found in the east (front) and south walls. Plate glass windows are found in the south, east, and north walls. Concrete and fabric canopies shelter the east doorway and some of the window bays. The building originally housed the Queensgate Medical Center (*Cincinnati Post and Times Star* 17 January 1969:3).

Plate 12. AL10, 911 W. Eighth Street, Bloc Ministries, looking west-southwest.

Under Criterion C, AL10 does not embody the distinctive characteristics of a type, period, or method of construction. The building is an unremarkable example of a small professional or medical office building. This portion of the building is relatively unaltered, although the rear portion of the west wall has fenestration replacements and a stucco coating on the wall. The building retains its overall integrity of location, design, setting, materials, workmanship, feeling, and association. AL10 lacks historical and architectural significance and is recommended as not eligible for listing in the NRHP.

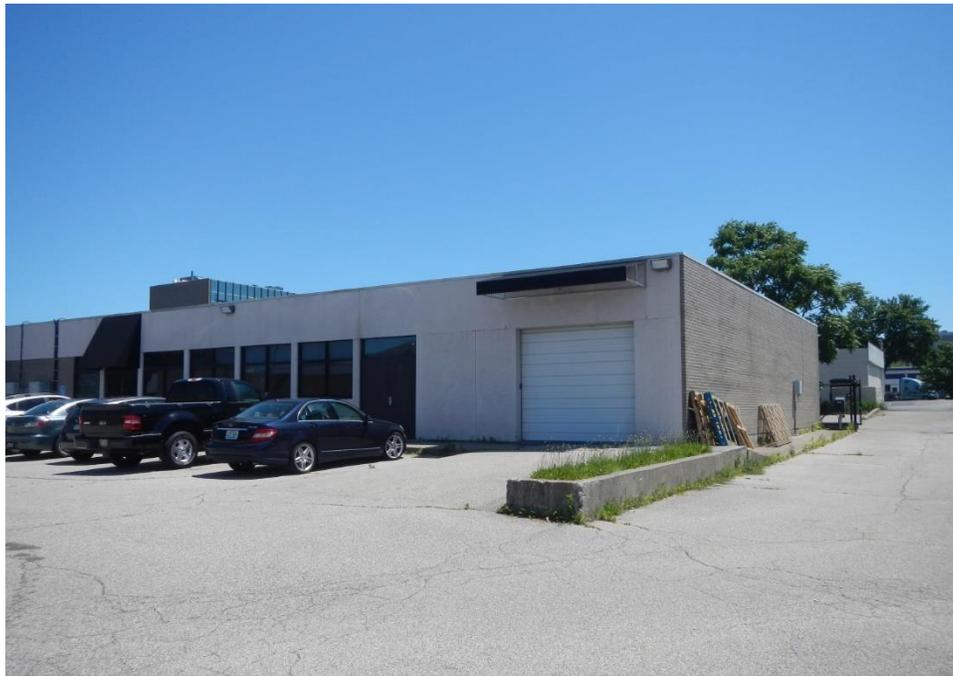
AL10 and AL11 are a single building, but have different owners and addresses in county tax records and so are discussed here separately. AL11 is a one-story warehouse building constructed in ca. 1969 (Figure 4, Sheet 3; Table 2; Plate 13). Like AL10, AL11 has a flat roof and a concrete foundation. The east and south walls are clad in brick veneer, but have no concrete posts dividing the walls into bays. Most of the west wall is covered in stucco panels, and this wall also contains a row of plate glass windows, a glass doorway, and a metal garage door. A few metal doors also are found in the east wall. The building originally housed the Queensgate Medical Center (*Cincinnati Post and Times Star* 17 January 1969:3).

Plate 13. AL11, 909 W. Eighth Street, Accent on Cincinnati Event Planning, looking northeast.

Under Criterion C, AL11 does not embody the distinctive characteristics of a type, period, or method of construction. The building is an unremarkable example of a small professional or medical office building. This portion of the building is relatively unaltered, although the rear portion of the west wall has fenestration replacements and a stucco coating on the wall. The building retains its overall integrity of location, design, setting, materials, workmanship, feeling, and association. AL11 lacks historical and architectural significance and is recommended as not eligible for listing in the NRHP.

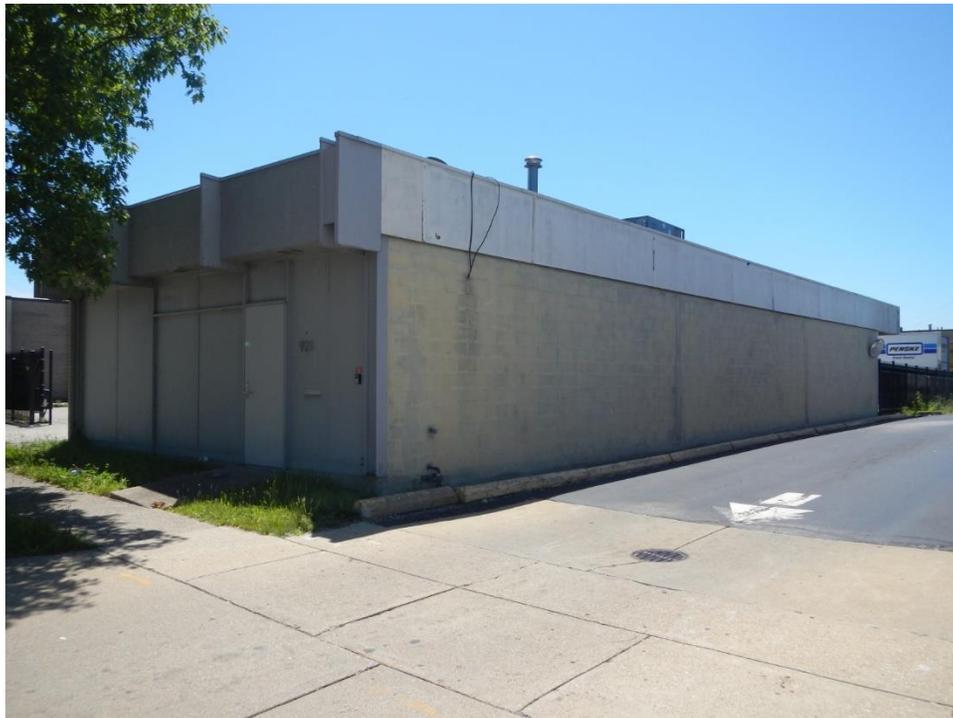
Plate 14. AL12, 921 W. Eighth Street, looking southeast.

Under Criterion C, AL12 does not embody the distinctive characteristics of a type, period, or method of construction. The building is an unremarkable example of a small professional office building. The building has lost integrity of design and materials due to alterations to its façade. AL12 lacks significance and integrity and is recommended as not eligible for listing in the NRHP.

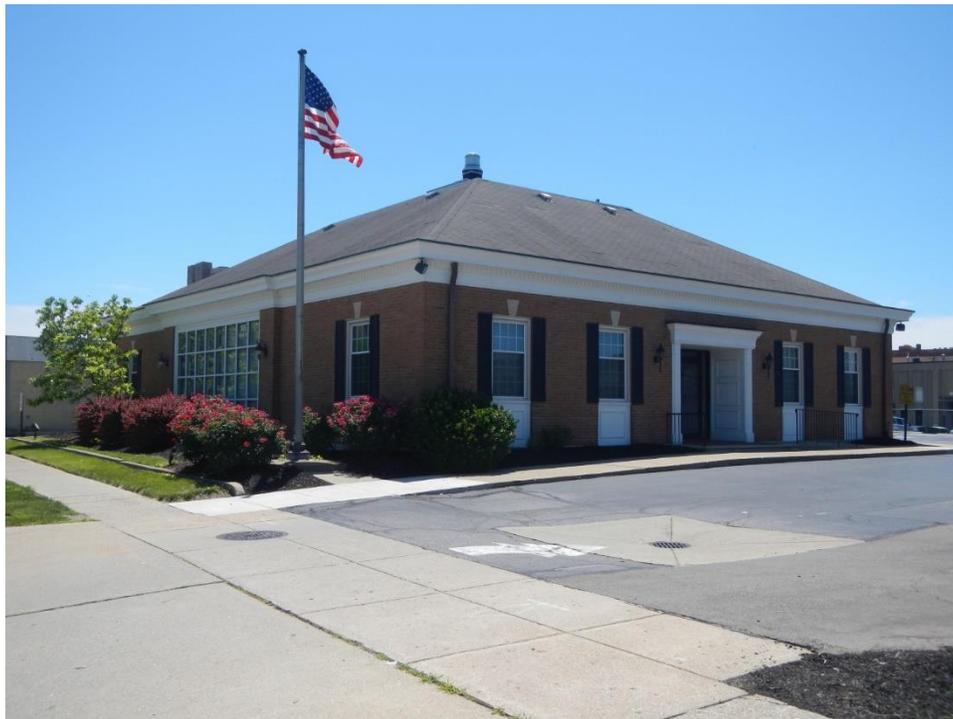
AL13 is a one-story Colonial Revival-style bank building constructed in 1972 (Figure 4, Sheet 3; Table 2; Plate 15). The building has a hipped roof covered in asphalt shingles. A cornice with dentils is located below the eaves. The foundation is concrete, and the walls are clad in brick veneer. A large picture window is located in the north (front) wall. The windows are modern replacements with keystones in the lintels and rectangular panels below the window openings. The recessed main entrance, located in the west wall, is framed by pilasters and an entablature. Research found no historical information regarding this building.

Plate 15. AL13, 925 W. Eighth Street, US Bank, looking southeast.

Under Criterion C, AL13 does not embody the distinctive characteristics of a type, period, or method of construction. The building uses Colonial Revival style ornament in a superficial manner in order to appear traditional and patriotic to appeal to customers and does not reflect the style in a meaningful way. The building retains its integrity of location, design, setting, materials, workmanship, feeling, and association. AL13 lacks historical and architectural significance and is recommended not eligible for listing in the NRHP.

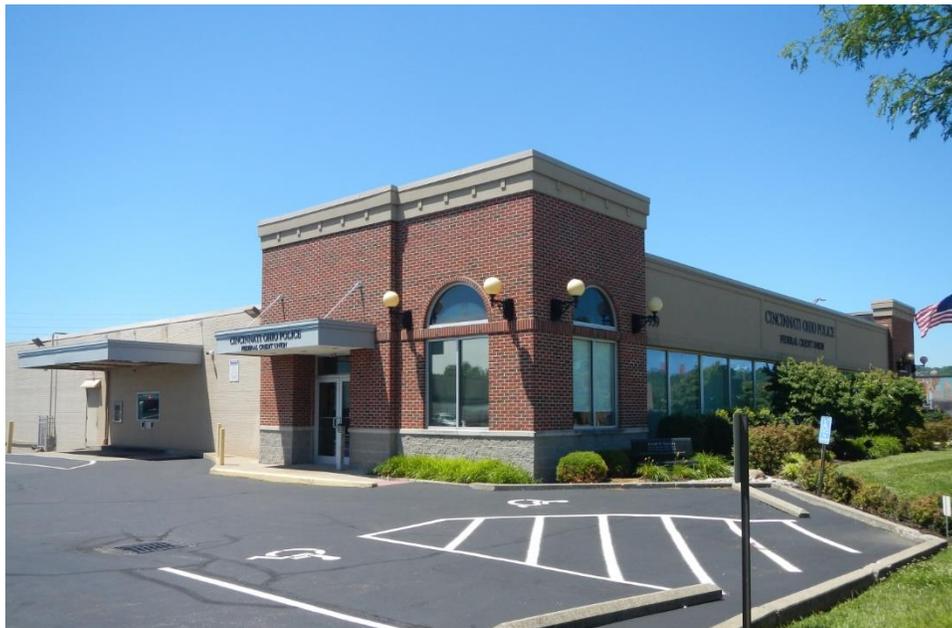
Plate 16. AL14, 959 W. Eighth Street, Cincinnati Ohio Police Federal Credit Union, looking southwest.

Under Criterion C, AL14 does not embody the distinctive characteristics of a type, period, or method of construction. The building has lost integrity of design, materials, workmanship, and feeling as a result of the replacement of the façade. AL14 lacks significance and integrity and is recommended as not eligible for listing in the NRHP.

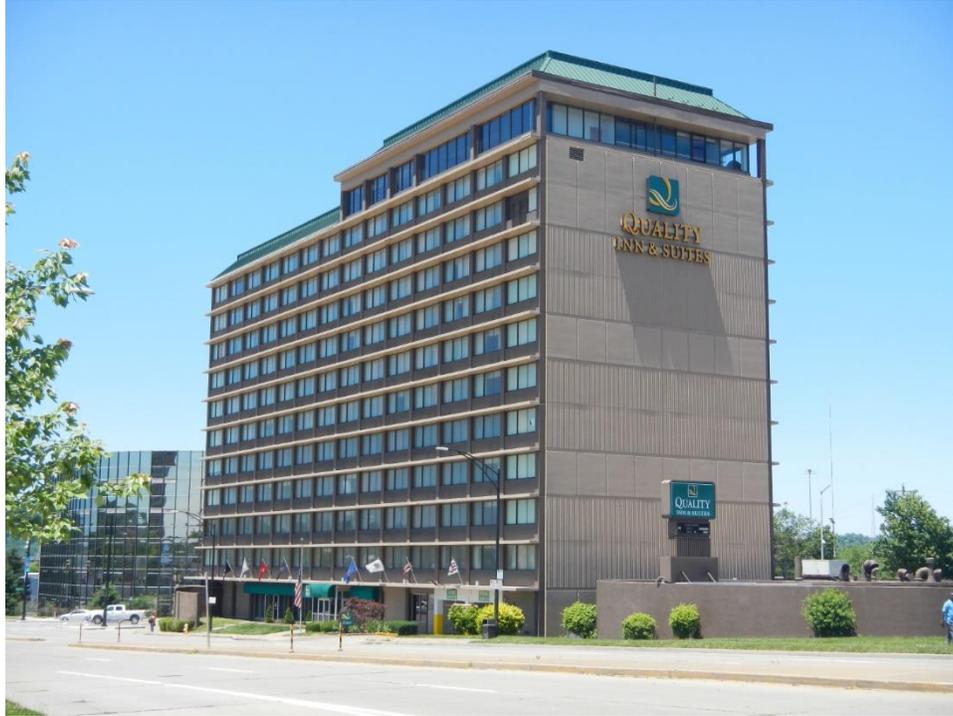
Plate 17. AL15, 800 W. Eighth Street, Quality Inn & Suites, looking northwest.

Under Criterion C, AL15 does not embody the distinctive characteristics of a type, period, or method of construction. Like many high-rise buildings of this period, the building's frame is expressed on its exterior in a modular grid pattern. The building lacks a glass curtain wall or a recessed ground floor to mark its design as Miesian style. The building retains integrity of location, design, setting, materials, workmanship, feeling, and association. AL15 lacks historical and architectural significance and is recommended as not eligible for listing in the NRHP.

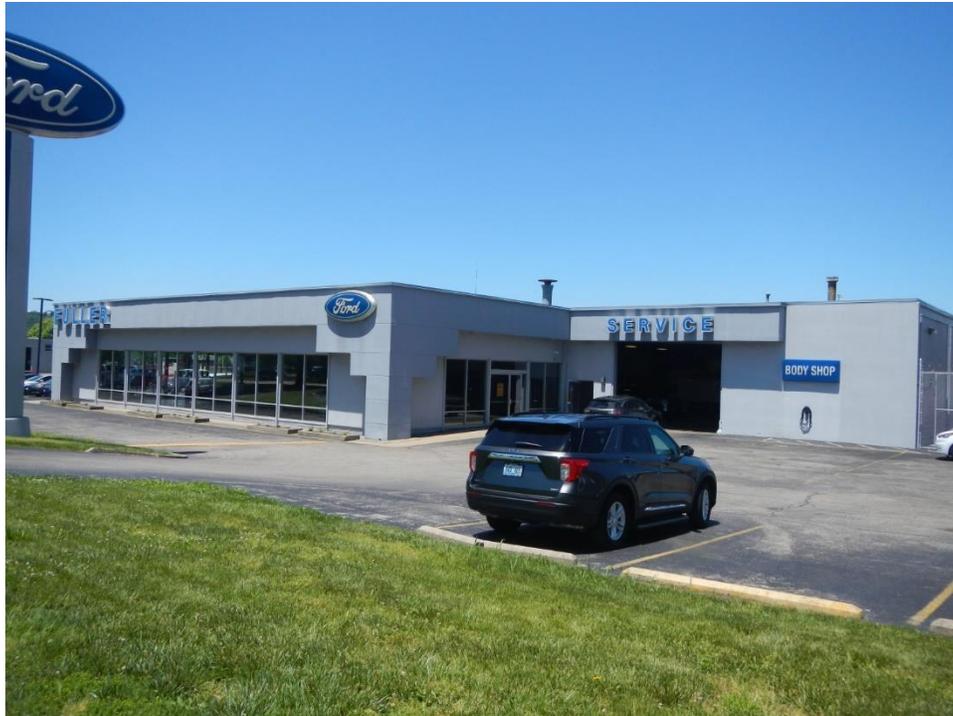
AL16 is a one-story automobile dealership building constructed in 1966 (Figure 4, Sheet 3; Table 2; Plate 18). The building has a flat roof and concrete block walls; the south end of the building is mostly coated with stucco. The south end of the building mostly consists of plate glass display windows for the showroom on the south (front), east, and west walls. Additional plate glass windows extend north along the east and west walls. One garage bay is found in the south wall east of the showroom, while additional garage bays are found in the north and west walls. A wing extends west from the northwest corner of the main building and also consists largely of garage bays. The showroom originally was completely enclosed with glass; the current stucco portions of the walls are a later alteration (Photo 7).

Plate 18. AL16, 900 W. Eighth Street, Fuller Ford, looking northwest.

Under Criterion C, AL16 does not embody the distinctive characteristics of a type, period, or method of construction. The building is an unremarkable example of a mid-twentieth century auto dealership, now heavily altered at the showroom, with extensively stucco wall sections replacing a formerly fully glass-enclosed space. AL16 lacks integrity of design and materials due to these alterations. AL16 lacks significance and integrity and is recommended as not eligible for listing in the NRHP.

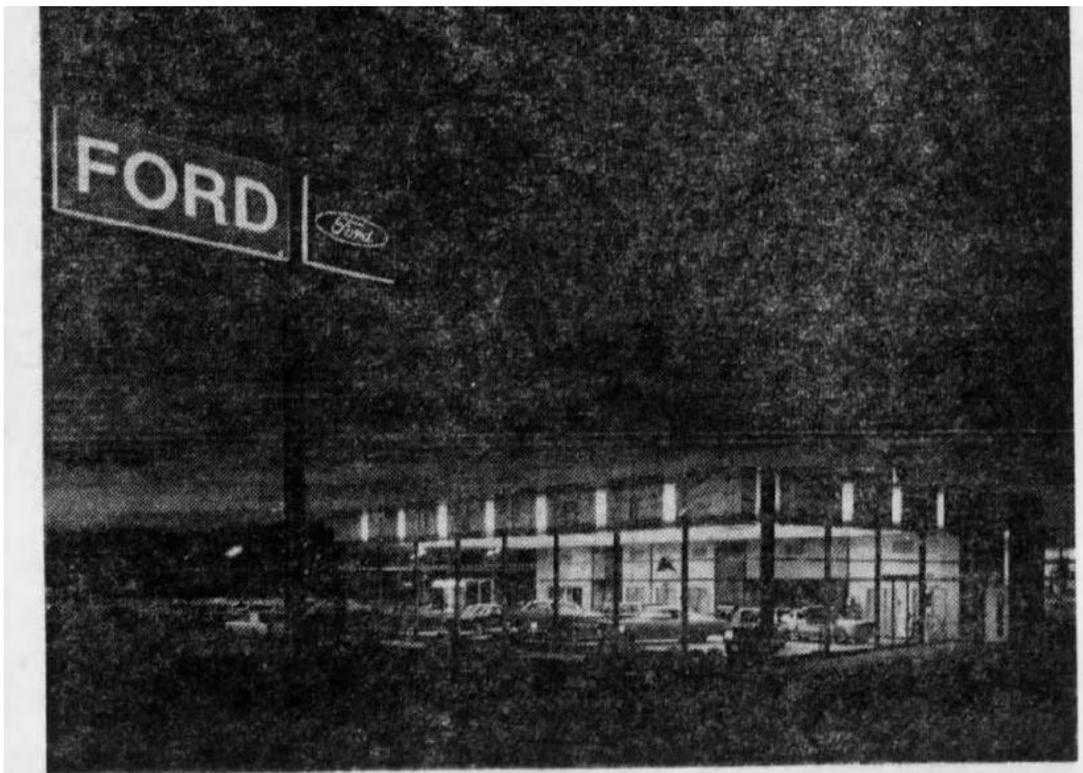
Photo 7. AL16, 900 W. Eighth Street, from *Cincinnati Enquirer* Queensgate I Day supplement 23 September 1971:9.

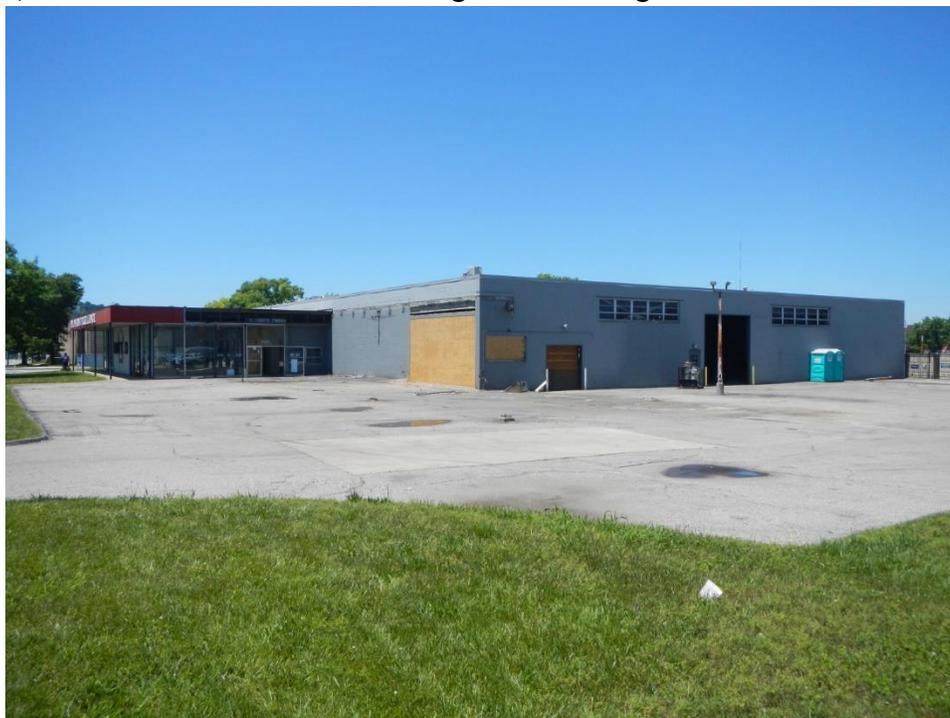
Plate 19. AL17, 950 W. Eighth Street, United Building Materials, looking northwest.

Under Criterion C, AL17 does not embody the distinctive characteristics of a type, period, or method of construction. The building is an unremarkable example of a mid-twentieth century auto dealership, now somewhat altered. The building retains its integrity of location, design, setting, materials, workmanship, feeling, and association. Lacking historical and architectural significance, AL17 is recommended as not eligible for listing in the NRHP.

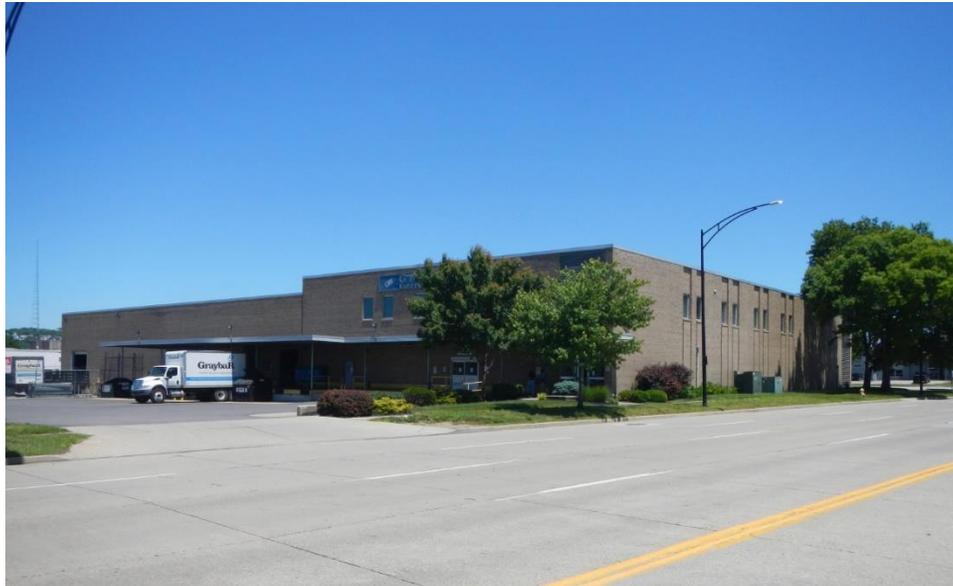
Plate 20. AL18, 1022 W. Eighth Street, Graybar, looking northeast.

Under Criterion C, AL18 does not embody the distinctive characteristics of a type, period, or method of construction. The building is an unremarkable example of a warehouse. The building retains integrity of location, design, setting, materials, workmanship, feeling, and association. AL18 lacks historical and architectural significance and is recommended as not eligible for listing in the NRHP.

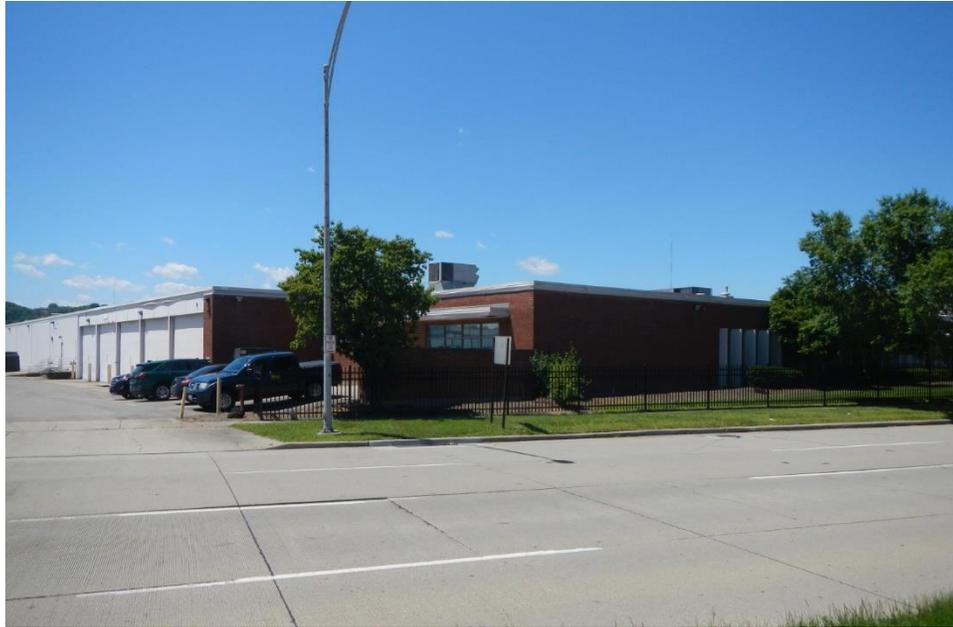
AL19 is a one-story warehouse building constructed in 1966 (Figure 4, Sheets 3 and 4; Table 2; Plate 21). The building has a flat roof and concrete block walls. The east (front) section of the building contains offices and is clad in brick veneer. The main entrance in the east wall has plate glass windows and glass doors under a metal canopy. The east wall also has bays of multiple plate glass windows separated by concrete dividers. The east end of the south wall of the warehouse section has five adjoining garage bays with metal doors. Apart from the replacement of original signage, the building has not significantly changed in appearance since it was built (Photo 8).

Plate 21. AL19, 925 Freeman Avenue, JBM Packaging, looking northwest.
