BRENT SPENCE BRIDGE PROJECT
Phase I History/Architecture
Re-evaluation Survey
HAM-71/75-0.00/0.22; PID 89068
City of Cincinnati, Hamilton County, Ohio

Submitted to ODOT-D08
July 2022

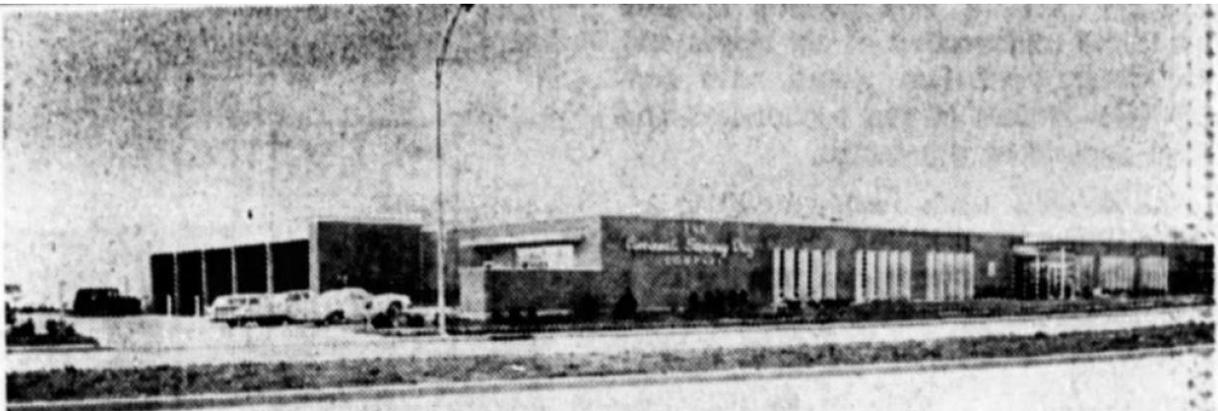
AL19 is a one-story warehouse building constructed in 1966 (Figure 4, Sheets 3 and 4; Table 2; Plate 21). The building has a flat roof and concrete block walls. The east (front) section of the building contains offices and is clad in brick veneer. The main entrance in the east wall has plate glass windows and glass doors under a metal canopy. The east wall also has bays of multiple plate glass windows separated by concrete dividers. The east end of the south wall of the warehouse section has five adjoining garage bays with metal doors. Apart from the replacement of original signage, the building has not significantly changed in appearance since it was built (Photo 8).

Photo 8. AL19, 925 Freeman Avenue, from *Cincinnati Enquirer* 1 May 1966:2-1.

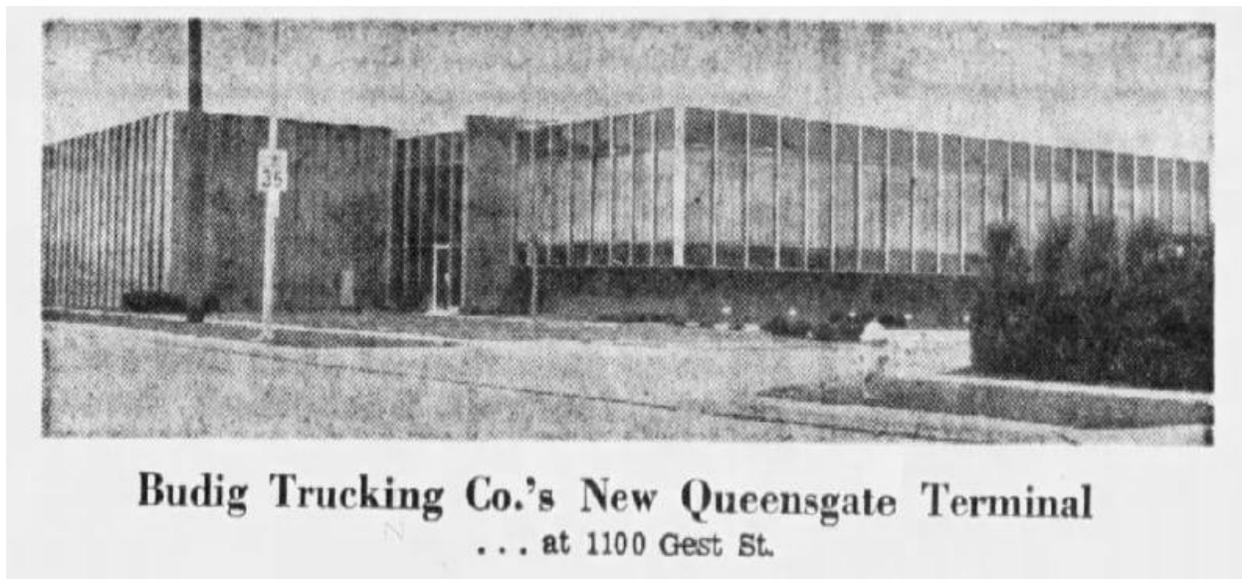
AL20 is a two-story warehouse building constructed in 1966 (Figure 4, Sheet 4; Table 2; Plate 22). The south (front) portion of the building has a flat roof and is clad in brick veneer. The north section of the building is one story, has a shallow-pitched gable roof, and is lined with loading docks. The east portion of the south section consists of offices and has a glass curtain wall above a brick veneer base. This section has a glass enclosed stairhall/atrium at the south wall. The building has not significantly changed in appearance since it was built (Photo 9).

Photo 9. AL20, 1100 Gest Street, from *Cincinnati Enquirer* 15 January 1967:11-E.

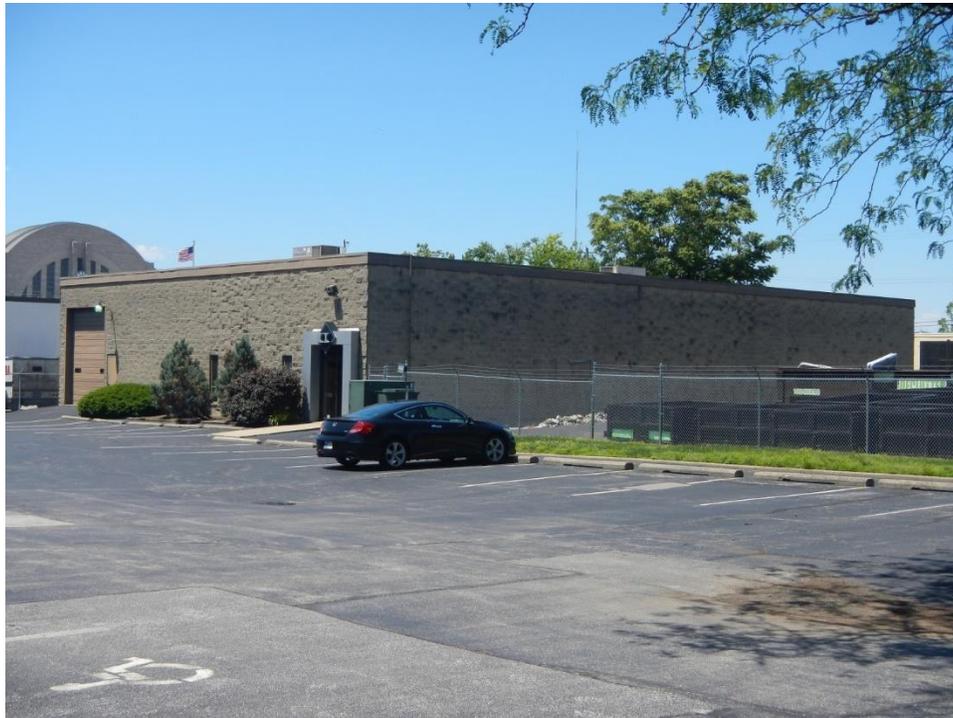
AL21 is a one-story warehouse building constructed in 1968 (Figure 4, Sheet 4; Table 2; Plate 23). The building has a flat roof and concrete block walls. Its main entrance is in its south wall; a garage bay with a metal door also is located in the south wall. Research was unable to identify the original use of this building.

Under Criterion C, AL21 is an unremarkable small warehouse building and does not embody the distinctive characteristics of a type, period, or method of construction. The building retains its integrity of location, design, setting, materials, workmanship, feeling, and association. AL21 lacks historical and architectural significance and is recommended as not eligible for listing in the NRHP.

Plate 23. AL21, 1155 Western Avenue, looking northwest.

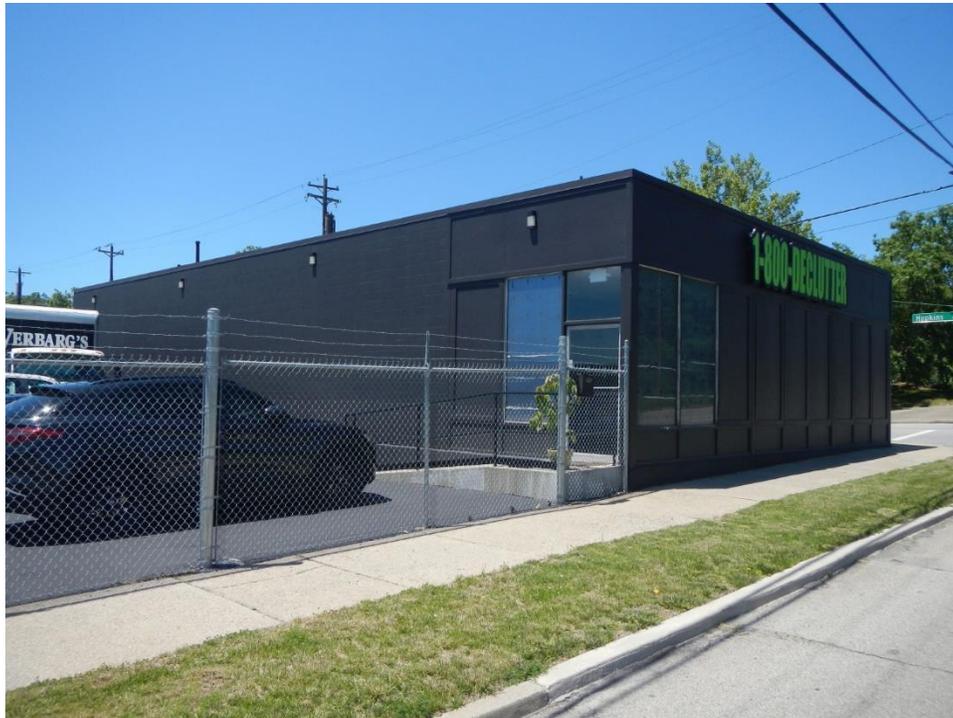
AL22 is a one-story commercial building constructed in 1964 (Figure 4, Sheet 4; Table 2; Plate 24). The building has a flat roof, a concrete foundation, and concrete block walls. Most of the north wall is clad in brick veneer. Metal panels cover most of the east (front) end of the building, although the southeast corner has plate glass windows and a glass door. Research was unable to identify the original use of this building.

Under Criterion C, AL22 is an unremarkable small commercial building and does not embody the distinctive characteristics of a type, period, or method of construction. The building has lost its integrity of design and feeling due to alterations to the front of the building. AL22 lacks significance and integrity and is recommended as not eligible for listing in the NRHP.

Plate 24. AL22, 1225 Hopkins Street, 1-800-declutter, looking northwest.

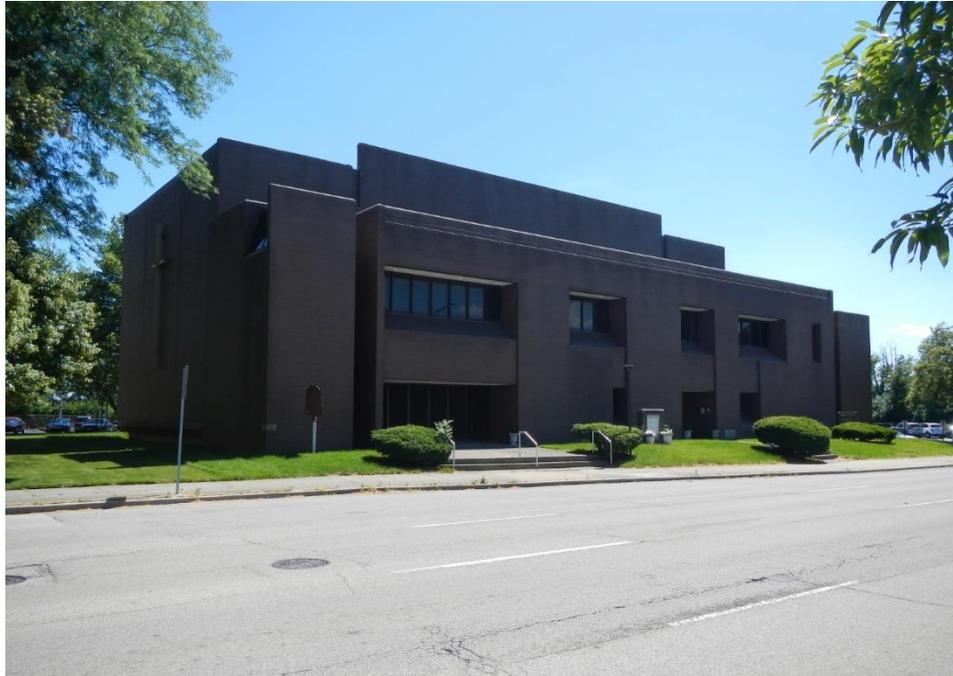
Under Criterion C, AL23 does not embody the distinctive characteristics of a type, period, or method of construction. The building's design does not incorporate any elements of Mid-Century Modern architectural style. Unlike many Mid-Century Modern churches that take traditional elements of church architecture, such as spires, bell towers, or buttresses, and incorporate them in creative ways, AL23 resembles a suburban office park building, and only a cross on its east wall marks its identity as a church. The building retains integrity of location, design, setting, materials, workmanship, feeling, and association. However, AL23 lacks historical and architectural significance and is recommended as not eligible for listing in the NRHP.

Plate 25. AL23, 405 W. Seventh Street, Union Baptist Church, looking southwest.
