Brent Spence Bridge Replacement/Rehabilitation Project

Bridge Type Selection Report

ODOT PID No. 75119
HAM-71/75-0.00/0.22
KYTC Project Item No. 6-17

March 2011

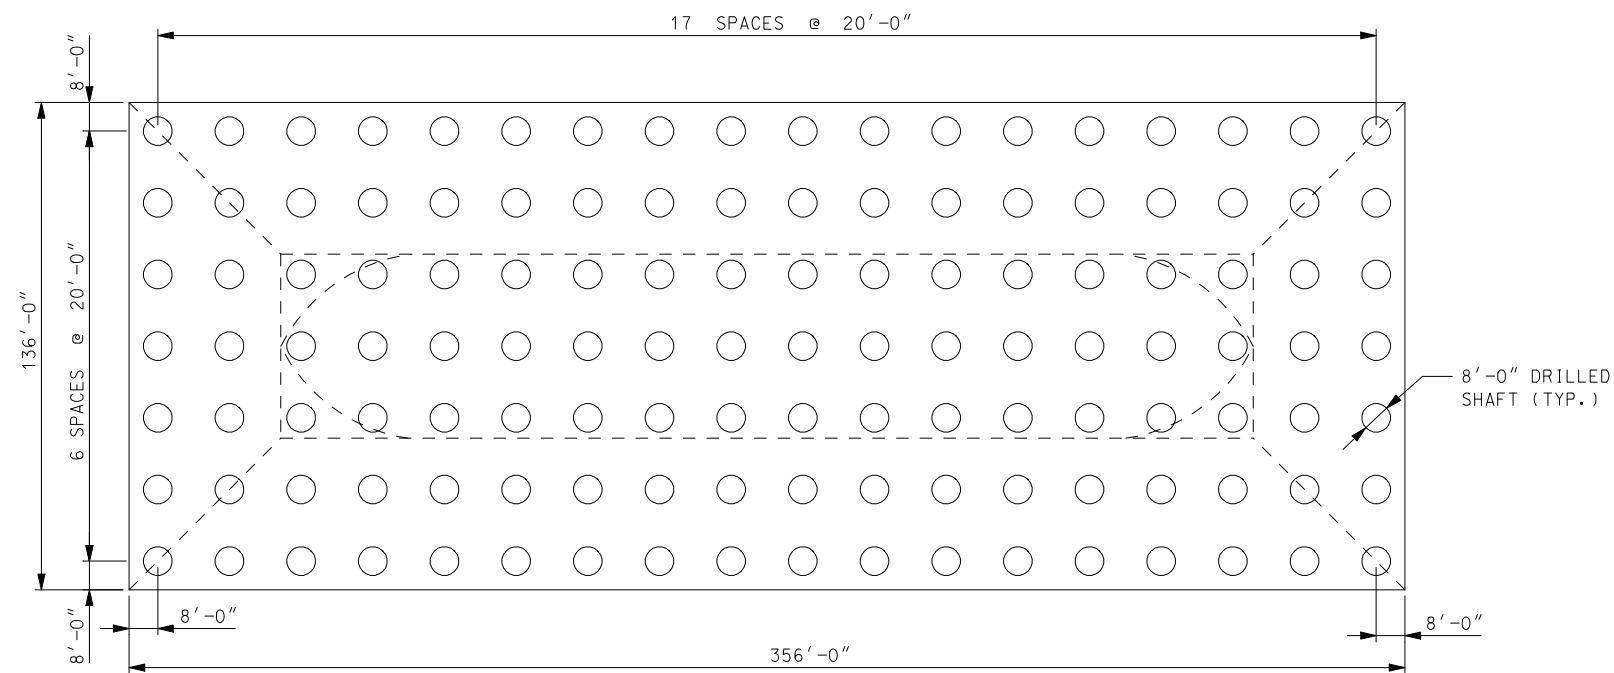
FOUNDATION PLAN
